Inspection Report

Property Address:
1234 Main Street
City State Zip Code

US Building Inspectors, Inc.

Date: 0/00/0000	Time:	Report ID: 7988SampleReport
Property: 1234 Main Street City State Zip Code	Customer: Your Name Here	Real Estate Professional:

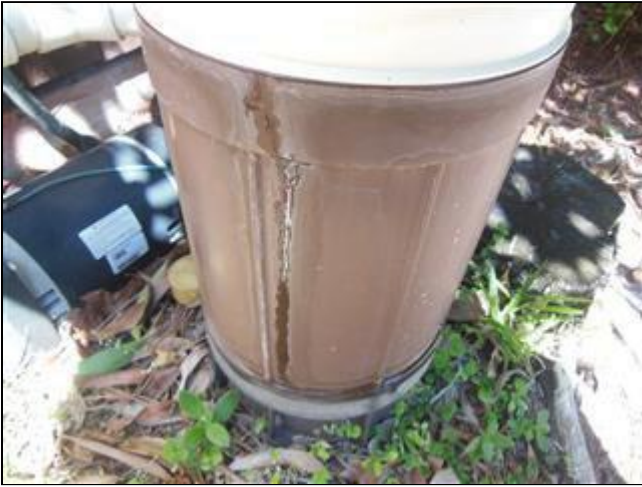
2.1 Picture 1

Pressure tank for water system is in need of repair. Calcification and is not working efficiently. (Picture 1)

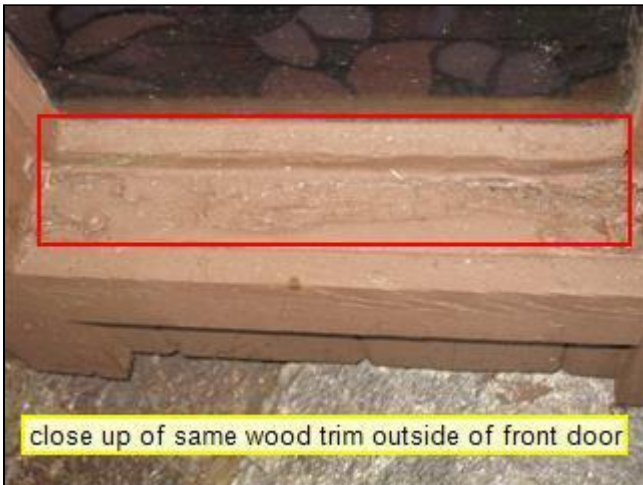
3.2 Picture 8

[] Some shell wall trim was evidenced with wood rot and some with other wood-destroying organisms. (Picture 6) (Picture 7)

3.1 <> Recommend evaluation by a licensed structural engineer or licensed trade professional for structural integrity after purchase, and after removal of T1-11 siding and any other covering.

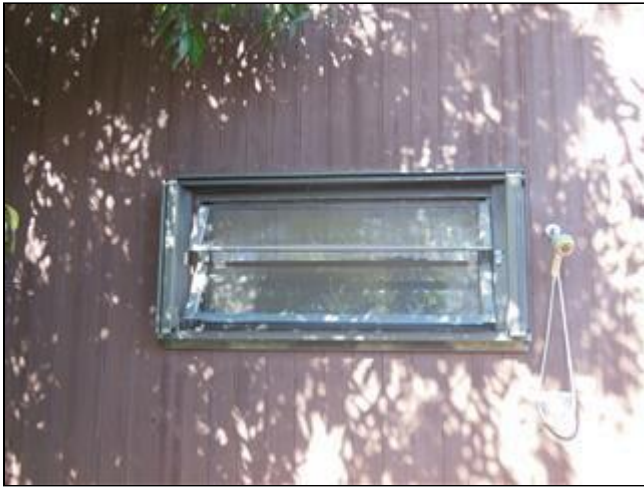
3.3 Picture 1

3.3 [] A representative number of windows were tested for functionality. Fixed pane glass windows in all areas need repair (new seals as the ones in place have deteriorated). Also awning vent windows are in need of being re-sealed/re-grouted. Same goes for horizontal sliding glass windows by wet bar. (Picture 3)

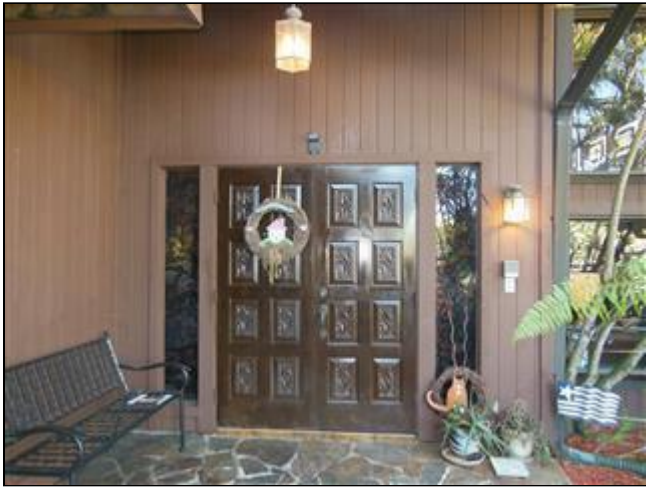
3.4 Picture 1

3.4 Double front entry doors - wood delaminated at bottom of doors - stationary door needs bottom latch repair. Bottom latch does not adequately fit into hole to stabilize the door at front entry door.

Side bathroom door appears to have some water damage.

Double rear entry doors need to be further evaluated for bottom of door water damage as well.

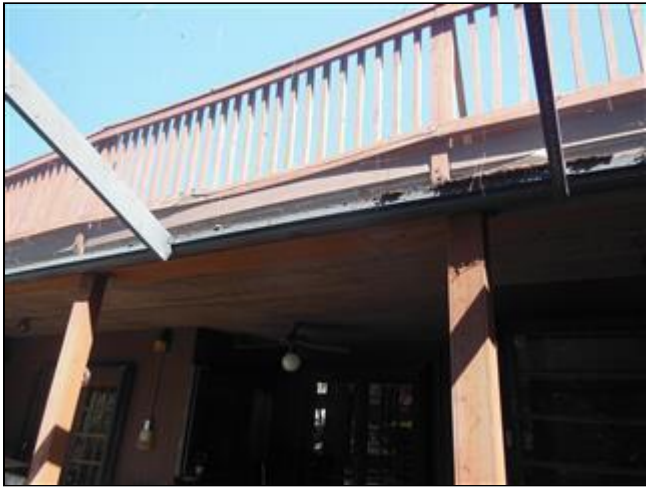
3.5 Picture 1

3.5 Rot present at front and rear balcony deck and railings.

Loose hardware present at the front and rear balconies.

> Recommend estimate/evaluations by a qualified building contractor.

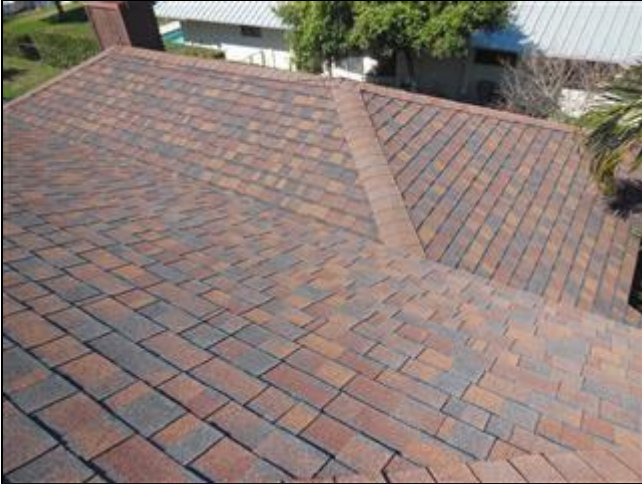
4.0 Picture 1

4.0 USBI is checking roof permit information - Listing agent stated that the roof covering was replaced in 2001. If this is so, the roof is 12 years of age. We will advise purchaser, even though he had a roofer inspect the roof, when the roof was permitted.

Evidence of subterranean and drywood termites present. Buyer or Seller should have wood-destroying organisms treated and affected wood structures replaced.

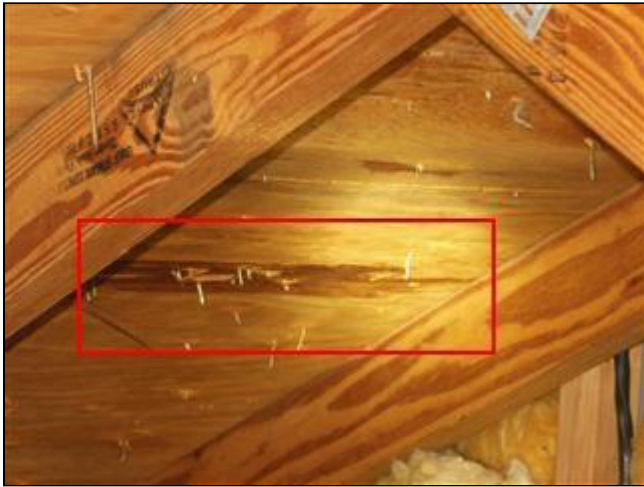
4.1 Picture 1

4.1 NOTE: The decking was not replaced when the roof covering was replaced. Unknown if the soffits and fascia were replaced when roof covering was. The decking inside the attic is the original decking when this roof was believed to have been covered with wood shake.

A large number of former roof leaks are apparent inside attic space.

The decking should be replaced, soffits, and fascia, and the structure of the roof should be more invasively evaluated once termites have been treated.

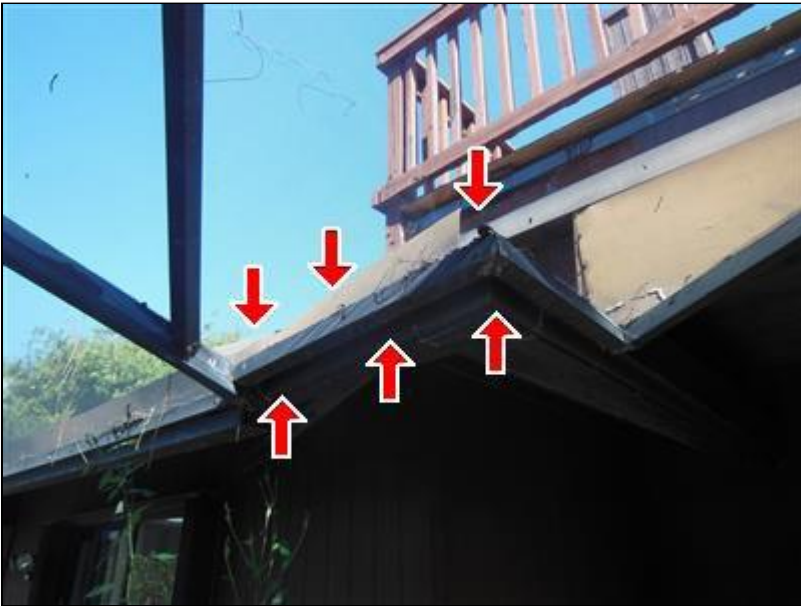
4.3 Picture 1

4.3 [] Several areas of flashing repair were needed. (Picture 1)

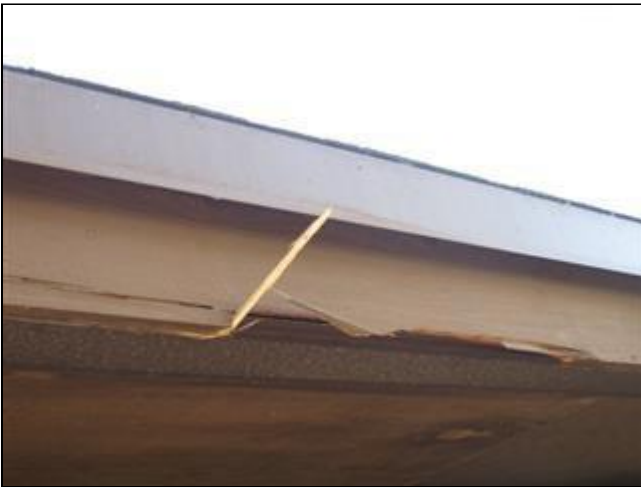
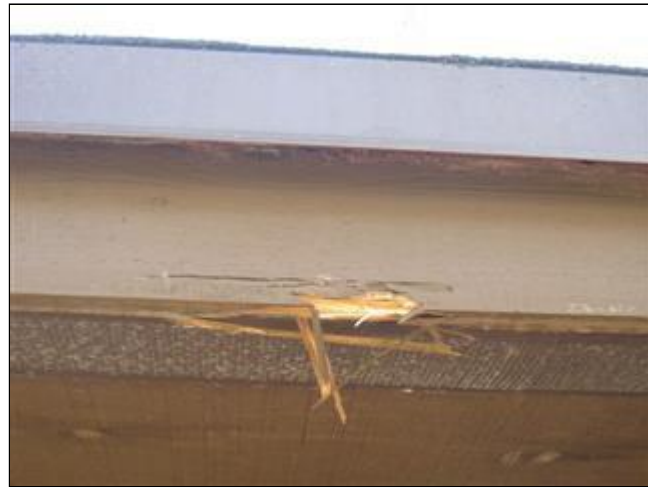
4.5 Picture 1

4.5 [] Many fascia boards are in need of replacement due to water intrusion, water damage, and wood-destroying organism damage. Pest control technician tested the wood fascia.

[] Some soffit areas were also affected by wood-destroying organisms and water damage. Wood-decaying fungi is a living organism, and where the soffits are damp or moist, they should be replaced with new wood.

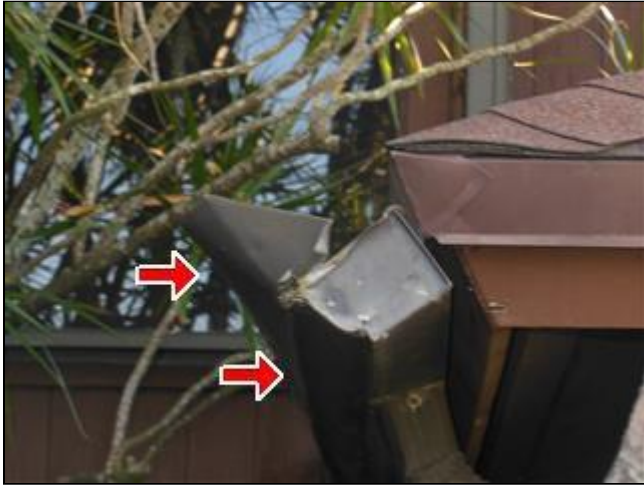
4.8 Picture 1

[] Minor gutter repair needed in limited areas. (Picture 1)

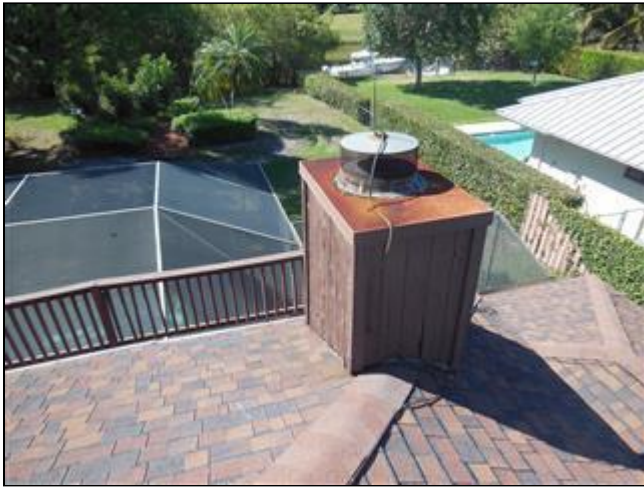
4.9 Picture 1

4.9 [] The chimney chase is frame and damaged by wood-destroying organisms and water damage. Wood rot is present, and all areas of affected wood should be treated, or replaced. Rust present. Recommend all components of the chimney, including the flue should be repaired.

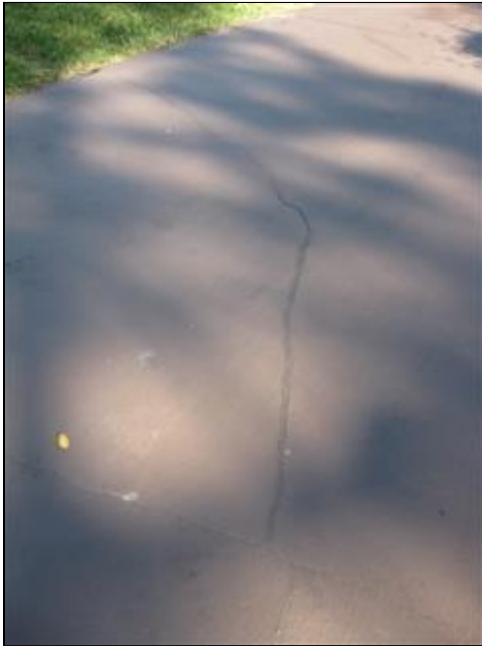
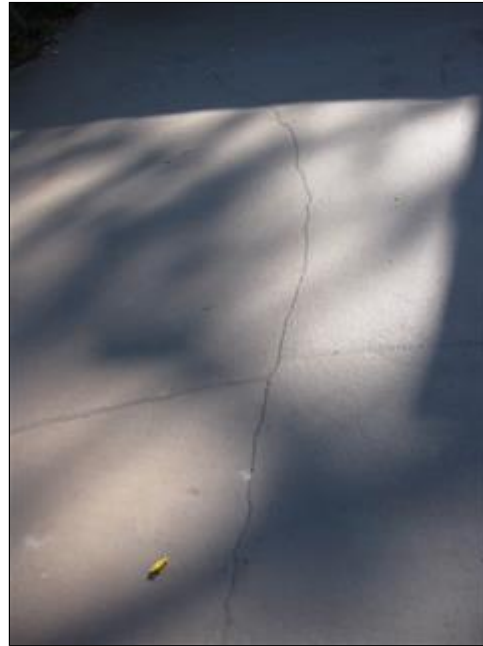
5.2 Picture 1

5.2 Observed cracking at the exterior concrete poured slabs. Cracking does not appear to be a structural failure at inspection time is is considered to be typical of like, kind and age.

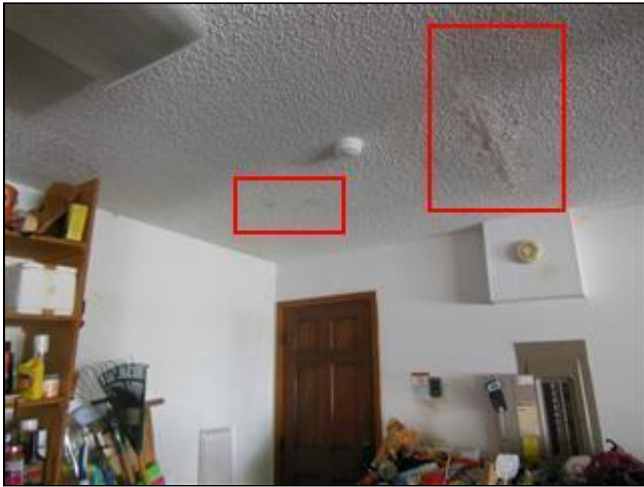
6.1 Picture 1

6.1 Portion of garage ceiling is evidence to have had water leaks. The water leaks may be active, or may be from the past; however, ceiling needs to be replaced in all affected areas. Repair work is substandard and should be redone by a licensed drywall professional.

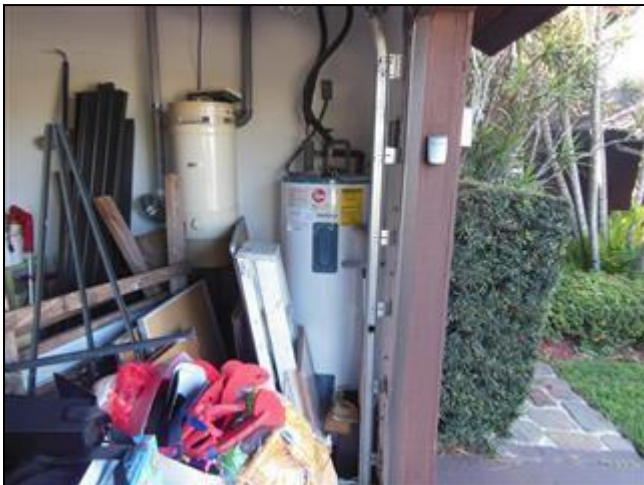
6.5 Picture 1

6.5 Excessive personal item storage present at the garage floor. This item is not accessible and not inspected at this time.

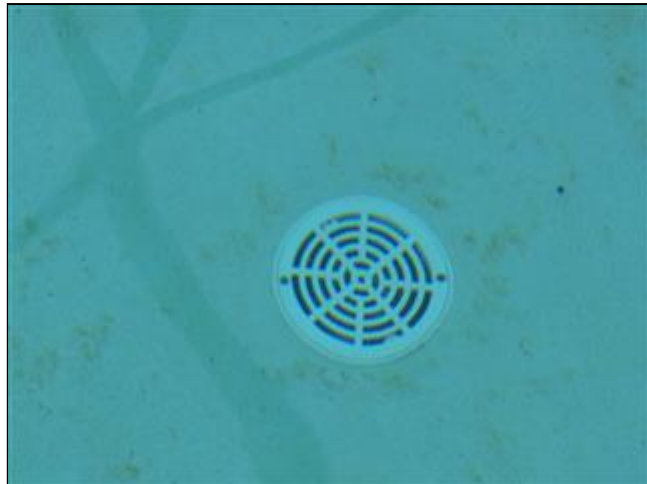
7.0 Picture 4

Recommend requesting estimates from several pool contractors - main drain cover appears to be properly secured (Picture 4)

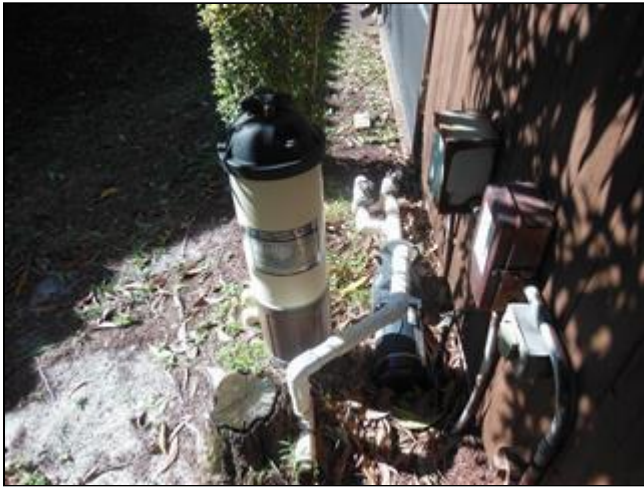
7.2 Picture 1

7.2 Hayward C-750 Pool Filter - was found to be leaking but not consistently leaking - may require new O-ring (gasket) - recommend further evaluation of this and pool pump as it is an old pump (and is half submerged under ground and may need to be replaced in the near future). Pool equipment should be under shade to prolong the life expectancy.

Electrical - timer works, recommend wires be serviced.

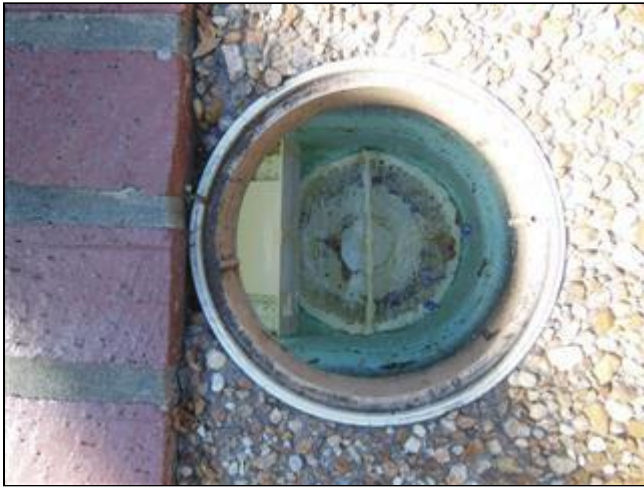
7.2 Picture 3

Skimmer needs replacement basket and cover for skimmer; recommend having pool skimmer dye tested for leaks. (Picture 3)

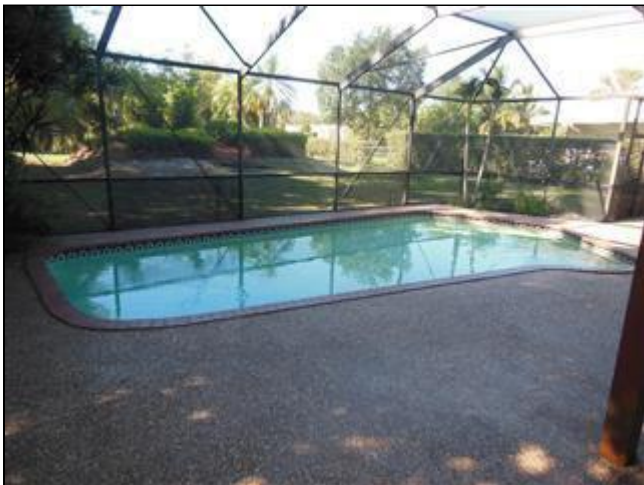
7.3 Picture 1

7.3 Pool deck - Chattanooga stone is small, fine pebbles mixed with epoxies to form a deck coating. Unfortunately, ultraviolet light attacks the epoxy which binds this system, and the product begins to deteriorate. The coating becomes porous and attracts bacteria, moisture and fine debris. Many cracks evidenced at the pool deck.

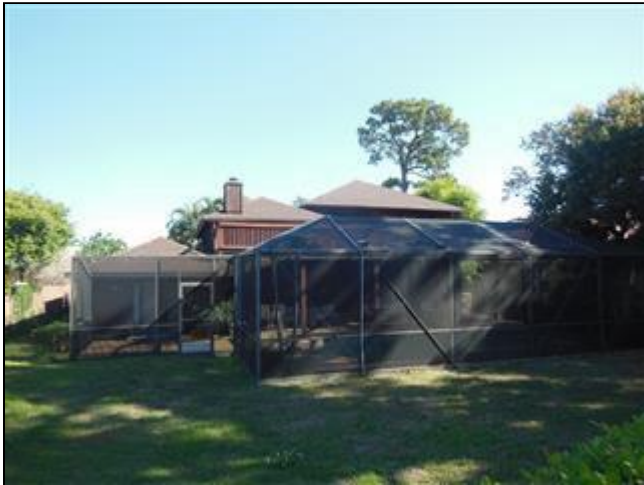
7.4 Picture 1

7.4 [] The pool enclosure is in need of some repair of screen and some re-splining.

[] More importantly, the overall pool enclosure structure is in poor condition in some areas. Some braces have rusted through and are in immediate need of repair or replacement. (Picture 2) Also some fascia boards in need of replacement of wood. (Picture 2 within square shape)

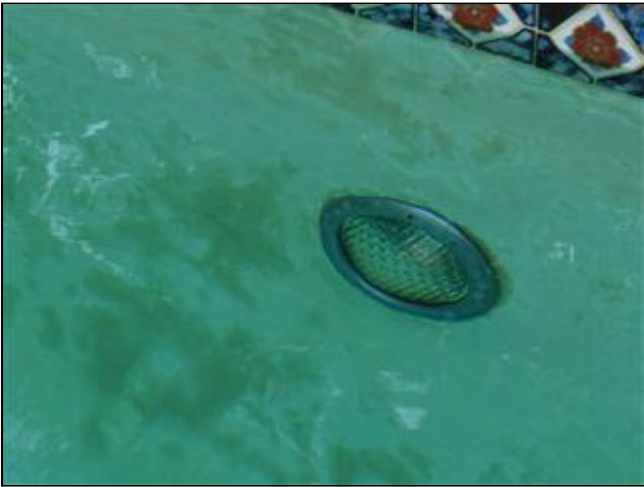
7.6 Picture 1

7.6 Pool light- did not work, recommend dye test to check for leaks.

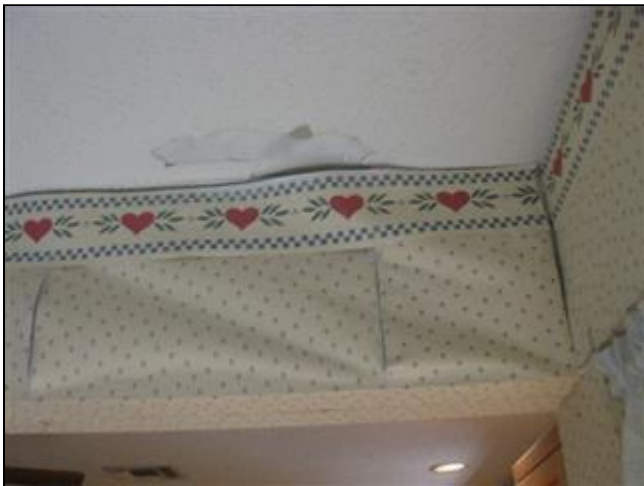
8.1 Picture 1

8.1 Evidence of past or present leak. No evidence to substantiate present leak. Would advise buyer to watch this area after several hours of hard pounding rain.

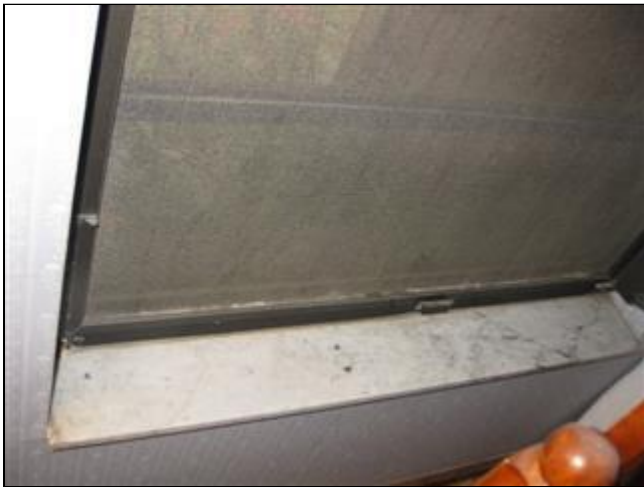
10.2 Picture 1

10.2 [] A number of windows in bathrooms were tested for functionality. Fixed pane glass windows in all areas need repair (new seals as the ones in place have deteriorated), same goes for awning vent windows in bathrooms. New seals are necessary.

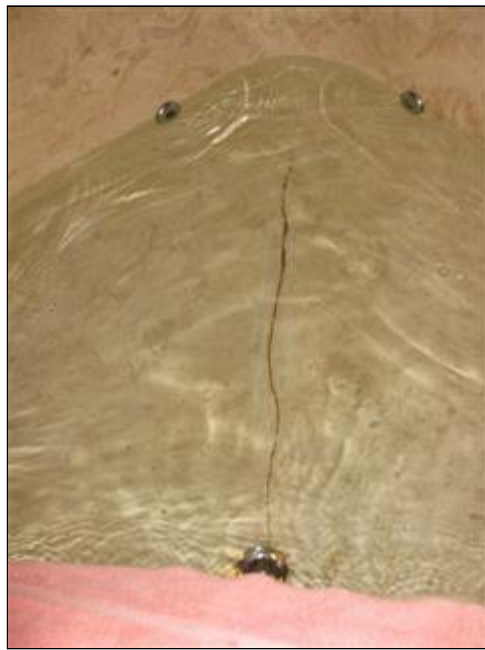
10.6 Picture 8

[] Spa tub in master bathroom was unable to be tested. Tried to fill it with water to fill over the jets; however, due to bottom of tub having a severe crack (Picture 8), the tub did not fill with water. Emptied tub of water and was unable to test spa tub motor. (Picture 5)

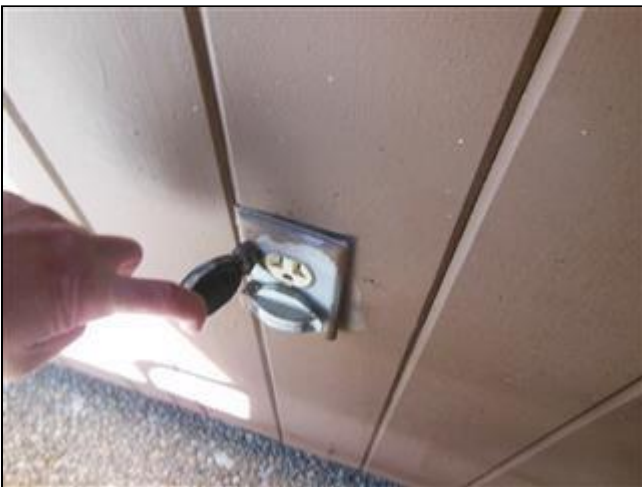
11.4 Picture 1

11.4 See Section 11.5 for exterior GFCI receptacles at the exterior of the home not working. In need of some new GFCI receptacles.

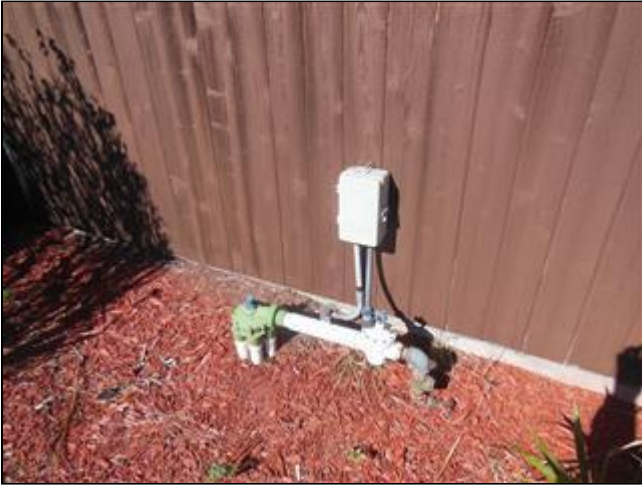
12.1 Picture 1

12.1 [] Irrigation (sprinkler) system pump in need of further evaluation. Did not show evidence of leaking (Picture 1)

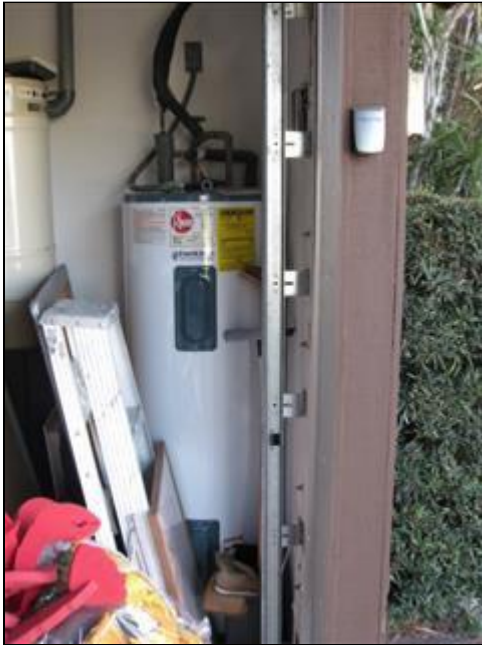
13.0 Picture 1

[] Water heater has many personal stored items surrounding it. This is a safety hazard. Nothing should be close to the water heater or stored around it. Water heater should have drain pan.

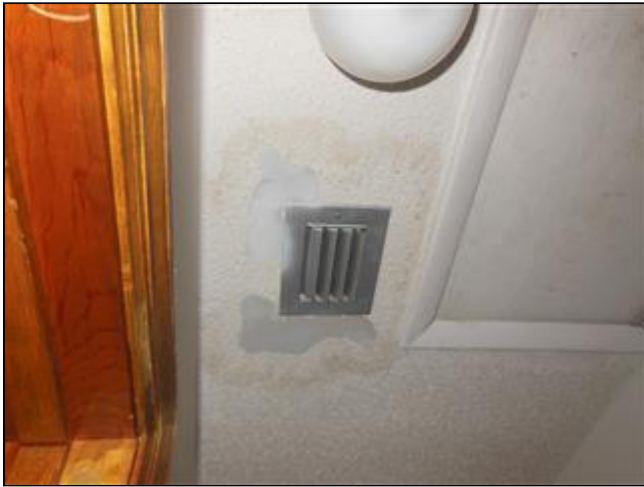
14.2 Picture 1

14.2 Evidence of past leak by registers/vents and intake/return.

Intakes and registers are filthy with dust and allergens. Duct work loaded with dust, wet moist mold-like substances, and in need of thorough cleaning and sanitizing.

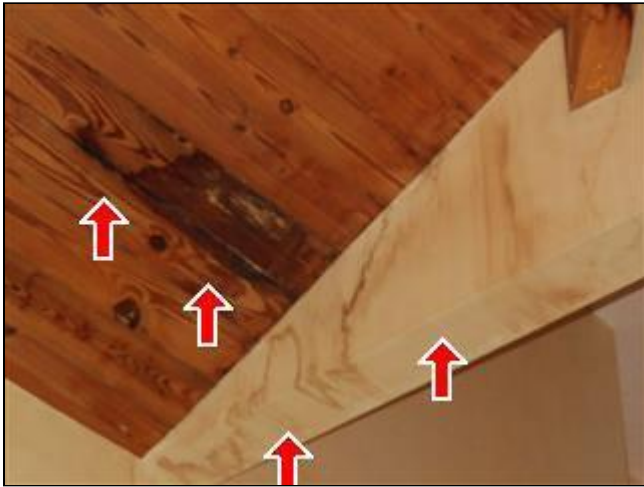
16.0 Picture 1

Ceiling inside of front entry is most likely from past leak in roof, but ceiling wood structure was never replaced. This area must be properly remediated and areas of wood replaced where most affected if wood is not capable of being salvaged.

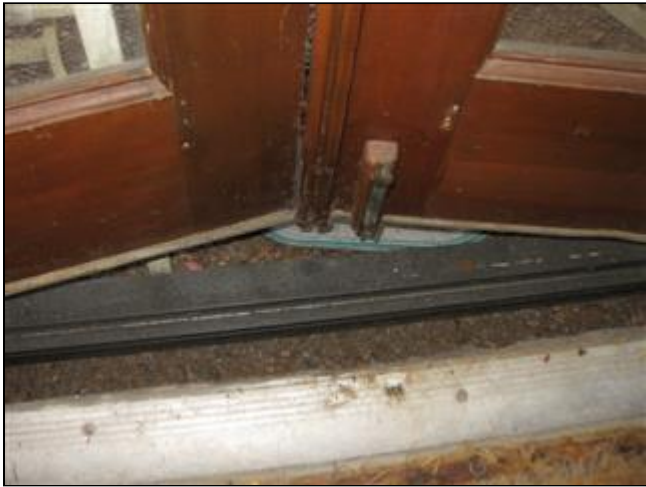
16.3 Picture 1

16.3 [] Double wood entry and egress doors have been affected by water damage from the past and are showing signs of delaminating.

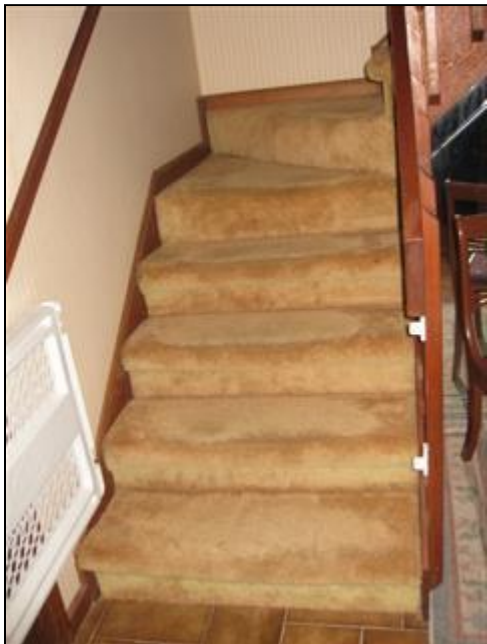
16.5 Picture 1

16.5 [] Carpeting and padding needs to be removed from stairs. The handrails appear to be in good condition and are secure. Handrails should be reinspected quarterly by the homeowner.
