Inspection Report

Property Address:
1234 Main Street
City State Zip Code

US Building Inspectors, Inc.

Date: 0/00/0000	Time:	Report ID: 7988SampleReport
Property: 1234 Main Street City State Zip Code	Customer: Your Name Here	Real Estate Professional:

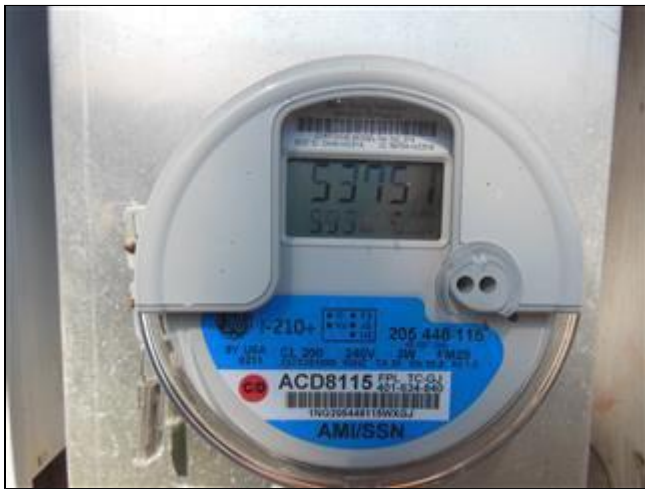
2.0 Picture 1

- 2.0 < Service / Utility is on at the time of inspection.
- > Electric main service panel is located at the exterior west wall.

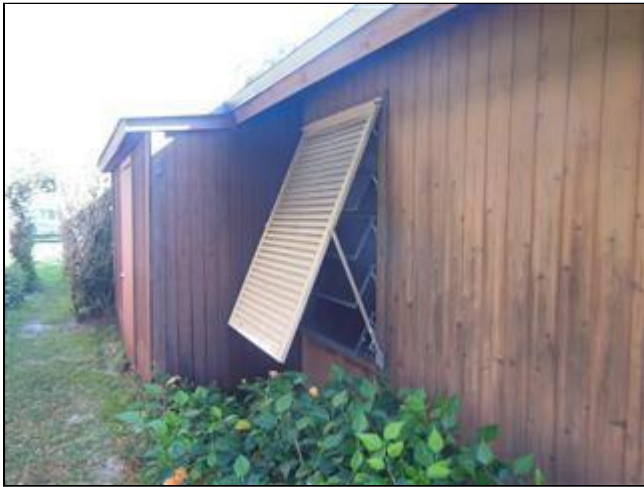
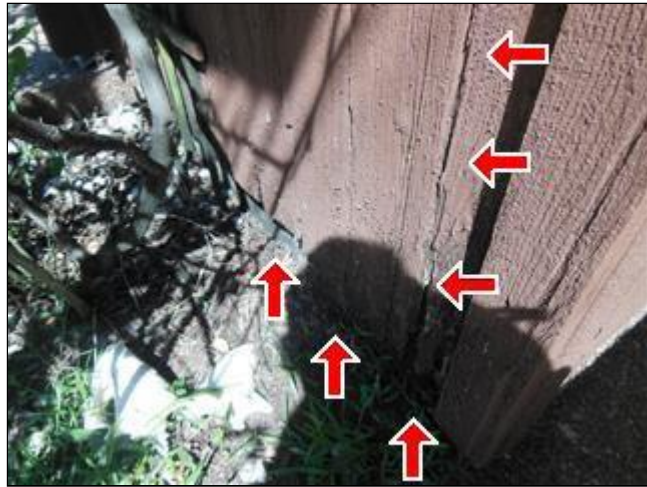
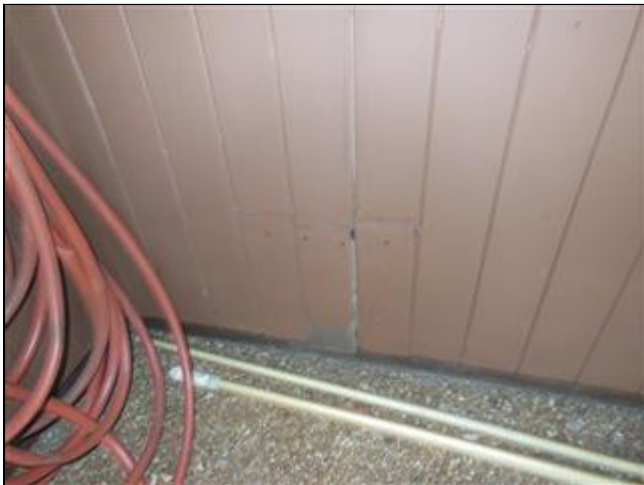
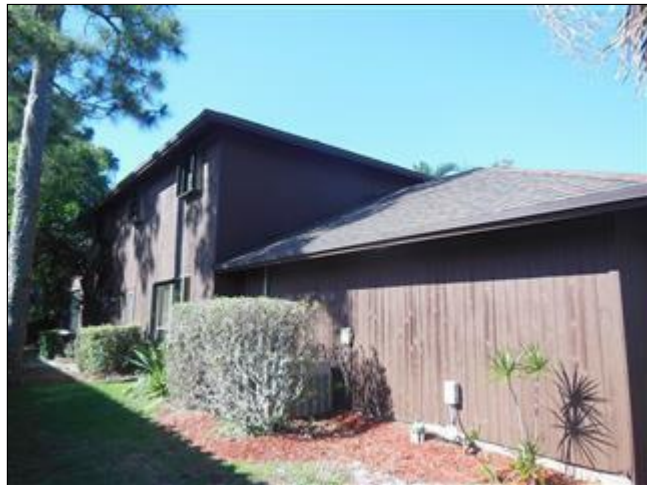
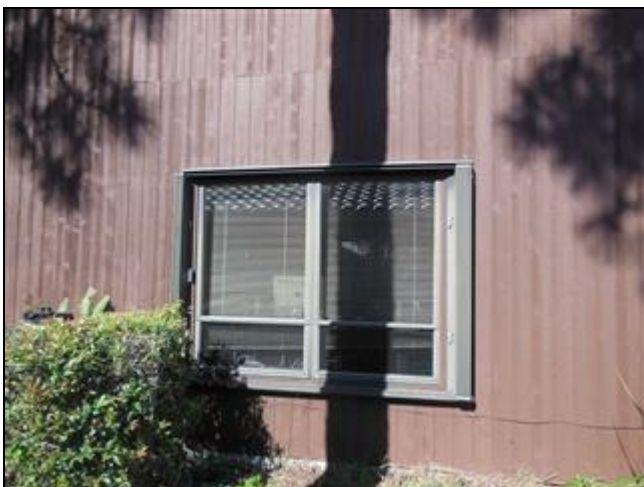
3.2 [] Shell construction siding and trim is in need of removal in order to determine structural integrity.

3.1 <> Recommend evaluation by a licensed structural engineer or licensed trade professional for structural integrity after purchase, and after removal of T1-11 siding and any other covering.

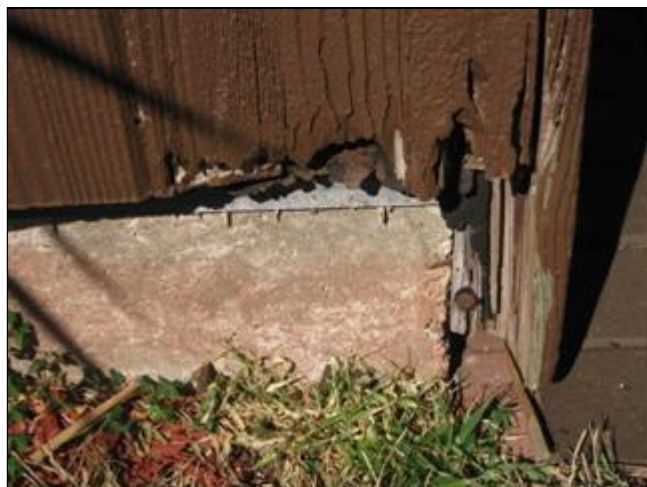
3.2 Picture 6

[] Some shell wall trim was evidenced with wood rot and some with other wood-destroying organisms. (Picture 6) (Picture 7)

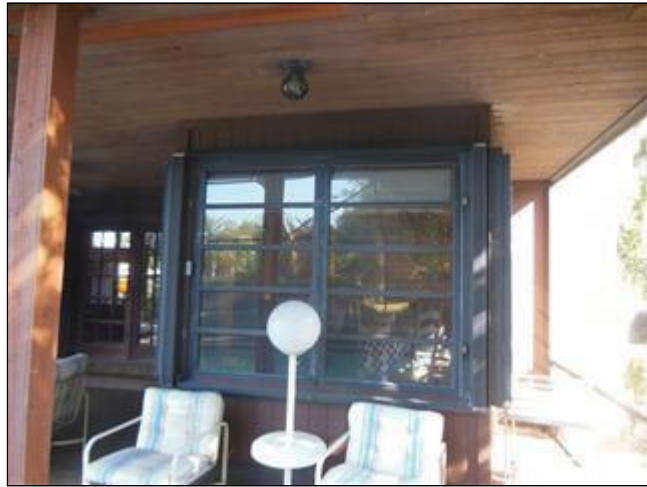
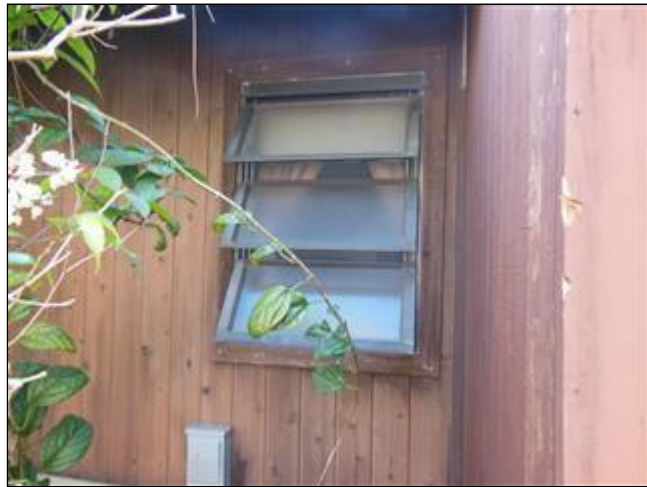
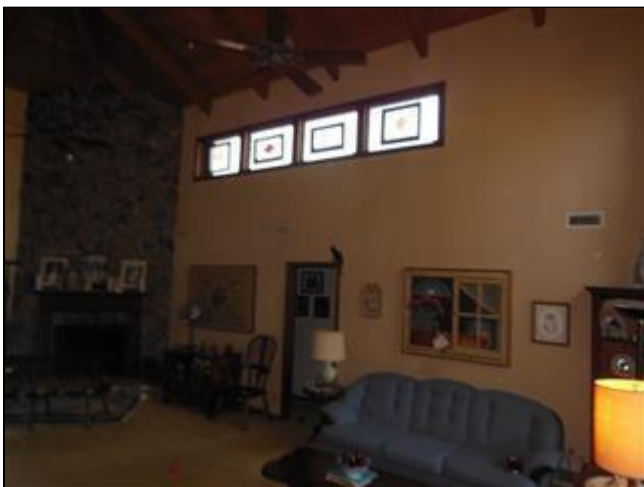
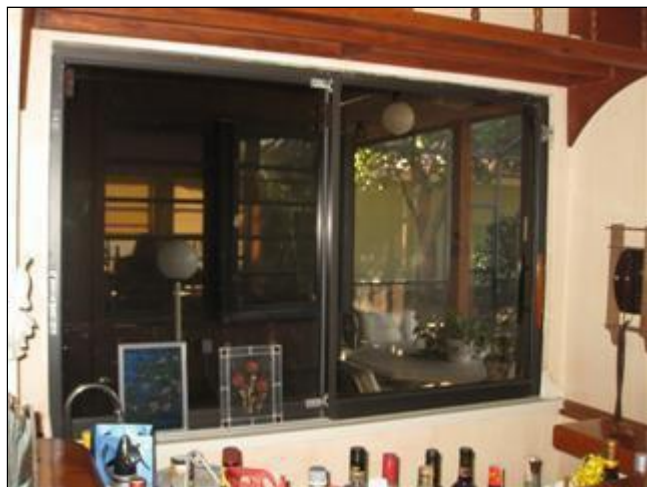
3.3 [] A representative number of windows were tested for functionality. Fixed pane glass windows in all areas need repair (new seals as the ones in place have deteriorated). Also awning vent windows are in need of being re-sealed/re-grouted. Same goes for horizontal sliding glass windows by wet bar. (Picture 3)

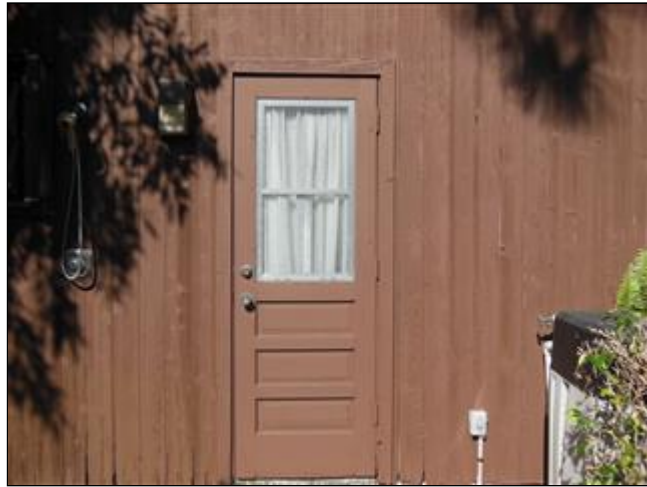
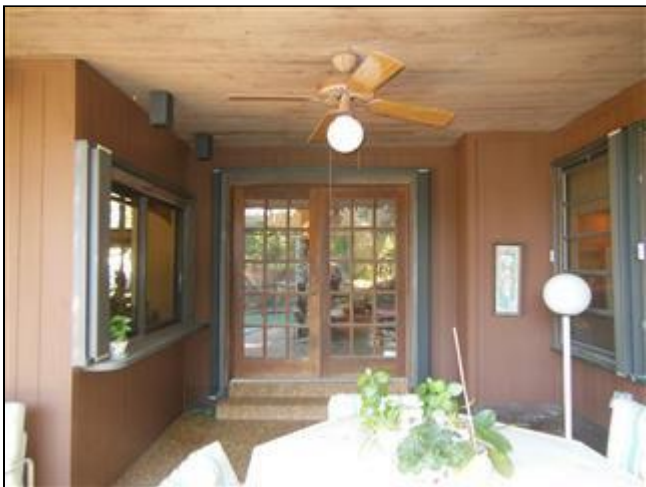
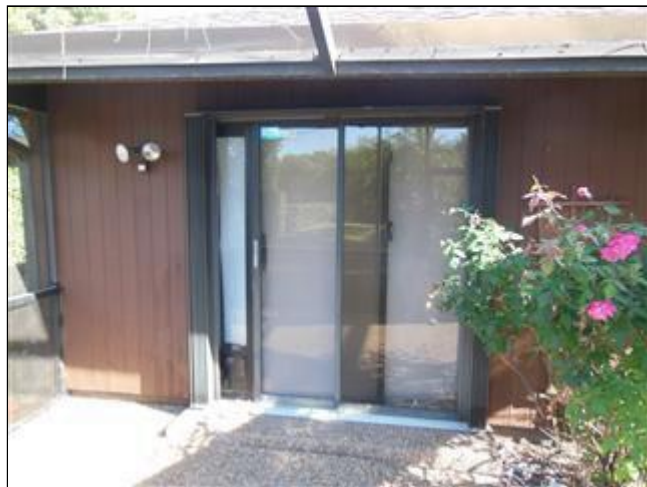
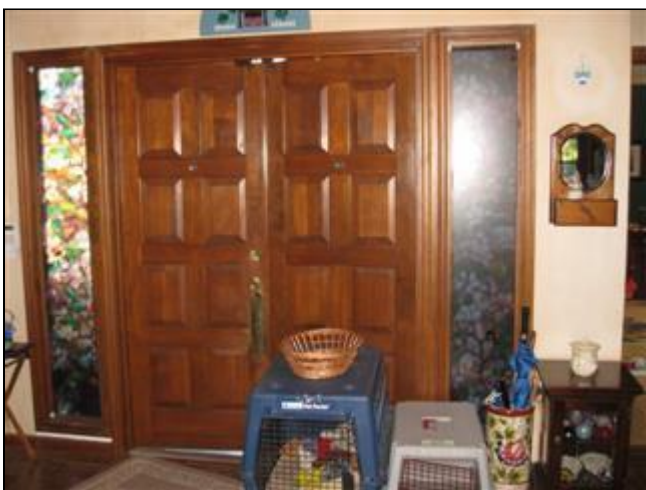
3.4 Double front entry doors - wood delaminated at bottom of doors - stationary door needs bottom latch repair. Bottom latch does not adequately fit into hole to stabilize the door at front entry door.

Side bathroom door appears to have some water damage.

Double rear entry doors need to be further evaluated for bottom of door water damage as well.

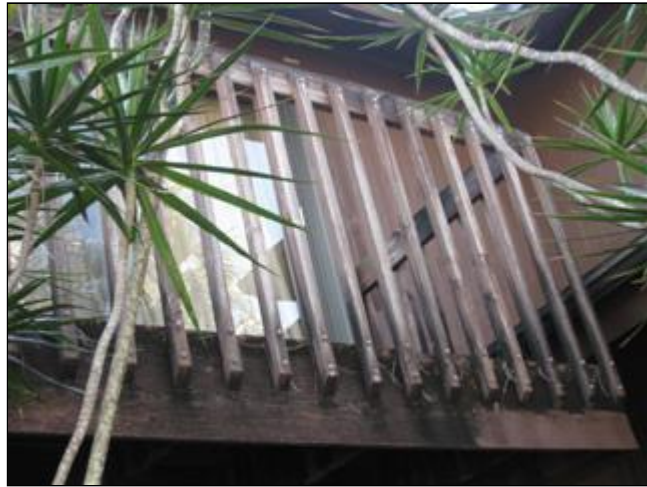
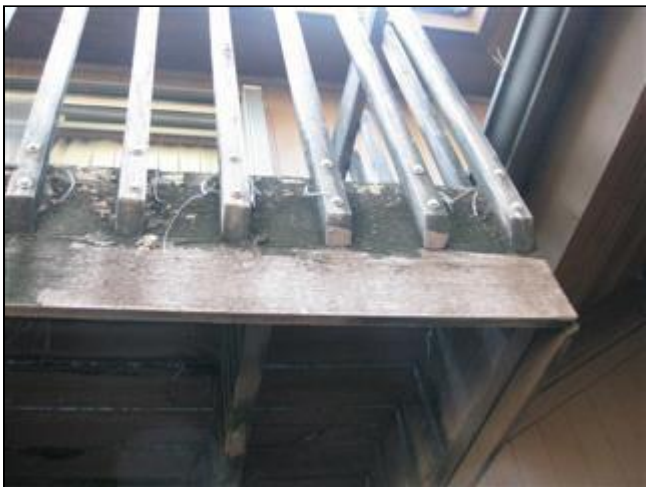
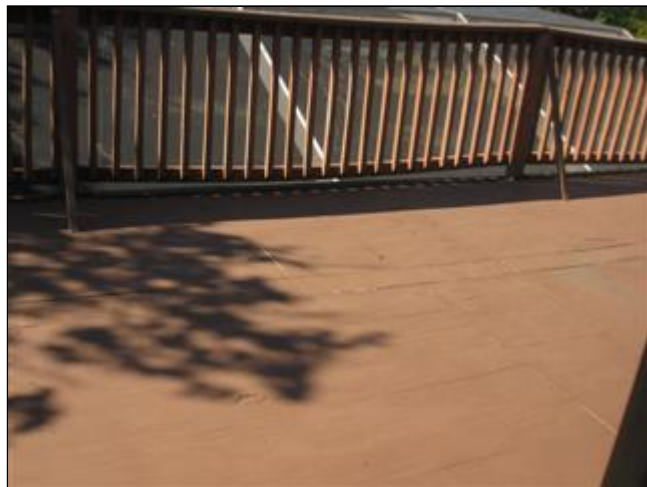
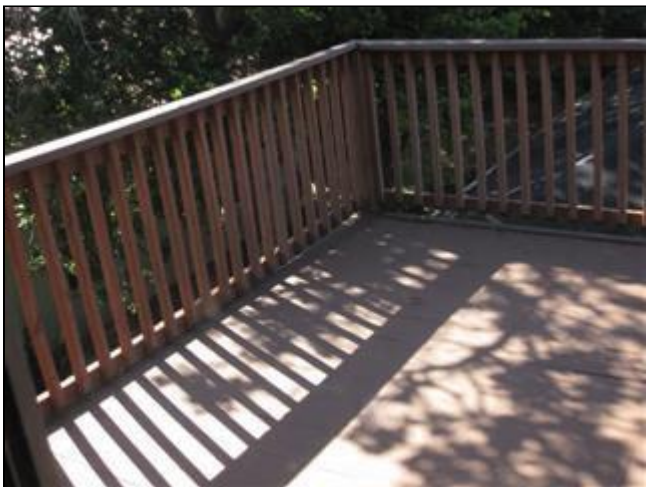
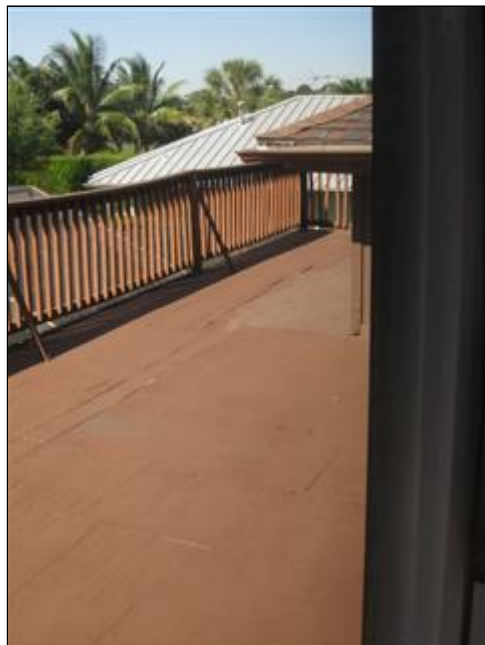
3.5 Rot present at front and rear balcony deck and railings.

Loose hardware present at the front and rear balconies.

> Recommend estimate/evaluations by a qualified building contractor.

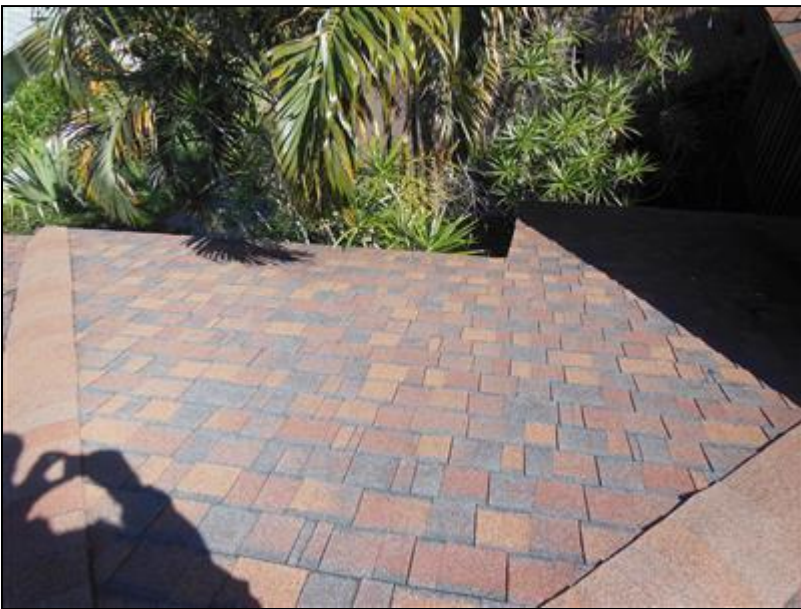
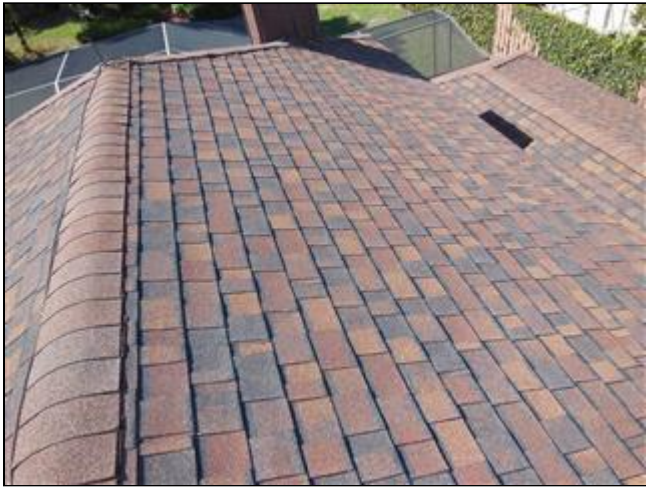
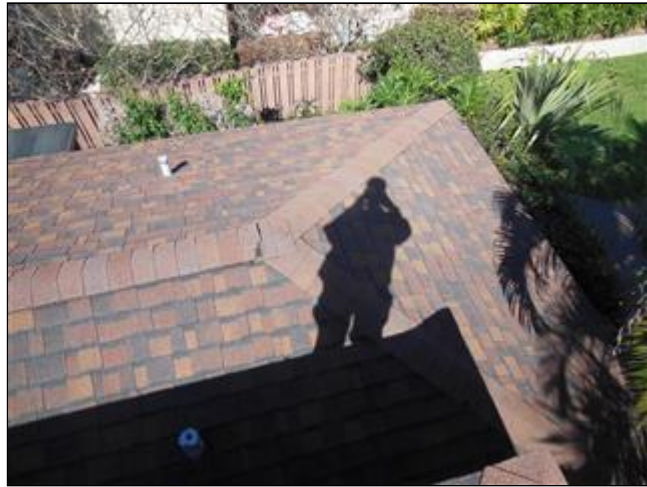
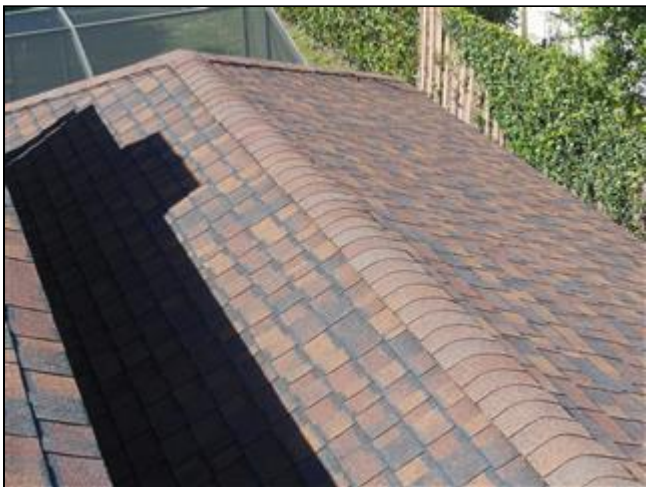
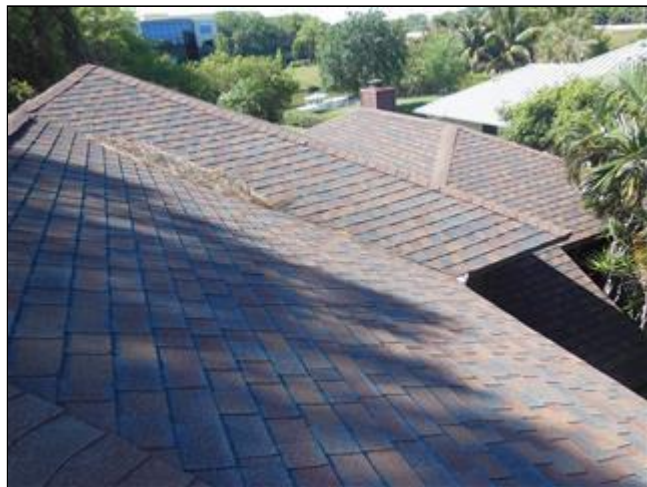
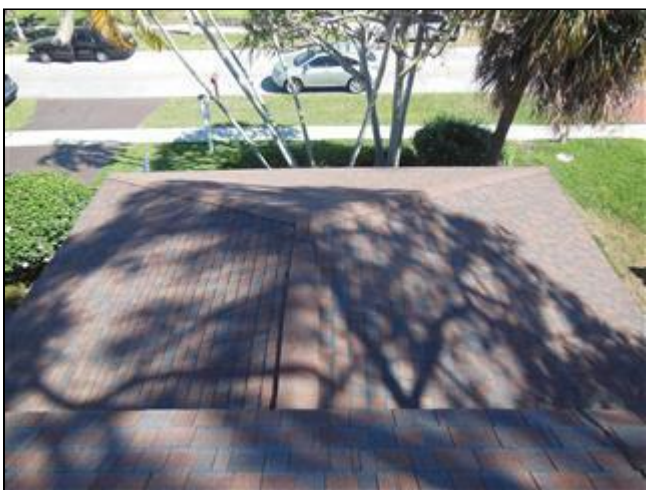
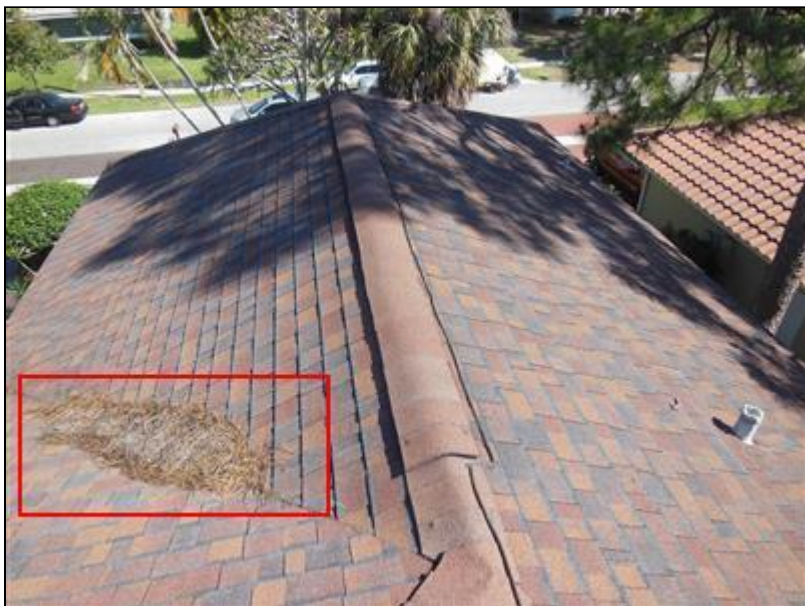
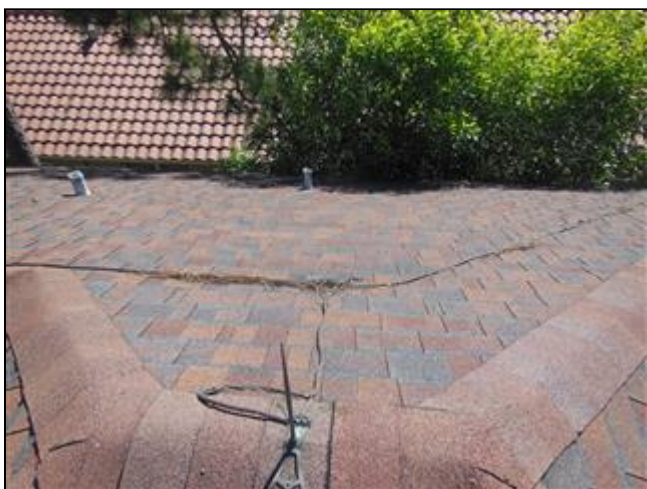
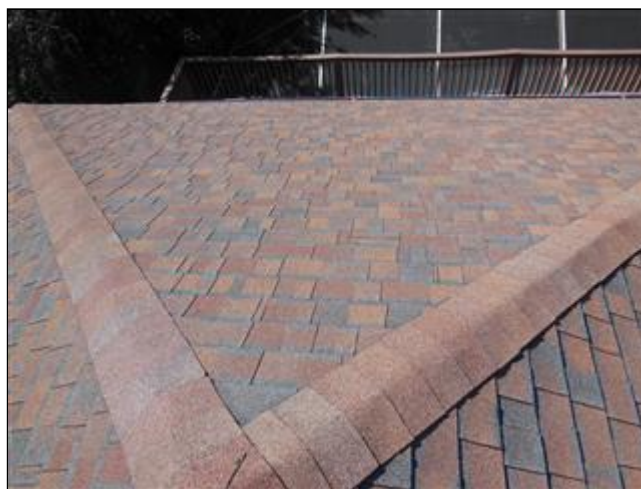
4.0 USBI is checking roof permit information - Listing agent stated that the roof covering was replaced in 2001. If this is so, the roof is 12 years of age. We will advise purchaser, even though he had a roofer inspect the roof, when the roof was permitted.

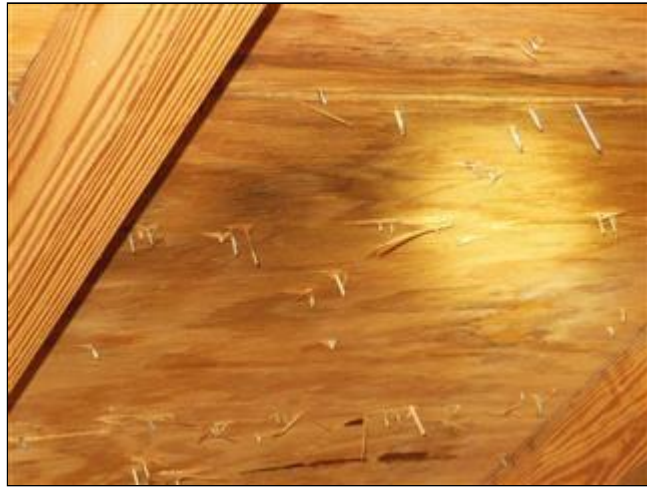
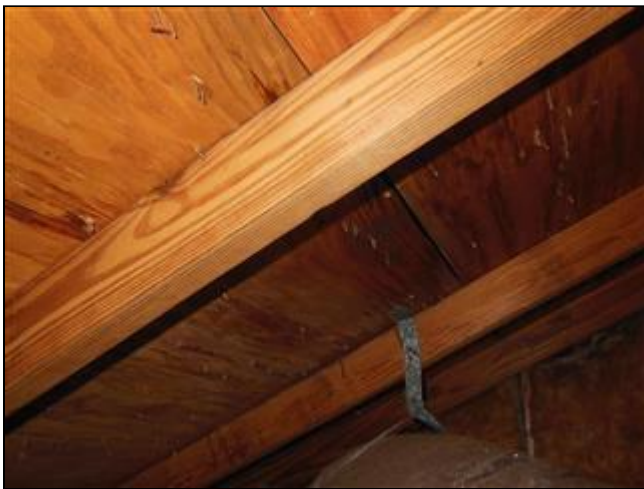
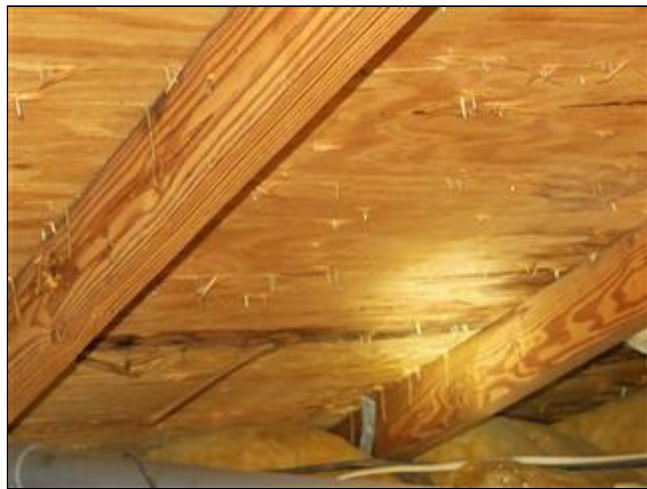
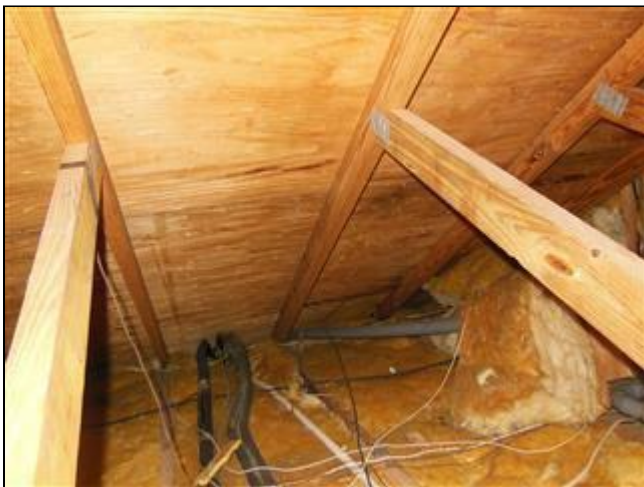
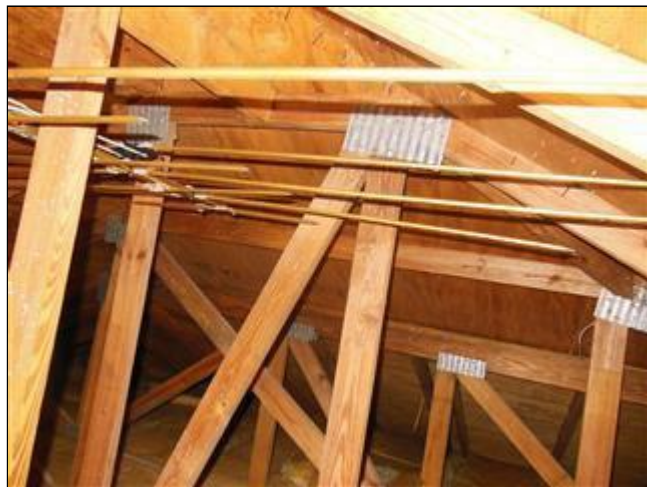
4.1 NOTE: The decking was not replaced when the roof covering was replaced. Unknown if the soffits and fascia were replaced when roof covering was. The decking inside the attic is the original decking when this roof was believed to have been covered with wood shake.

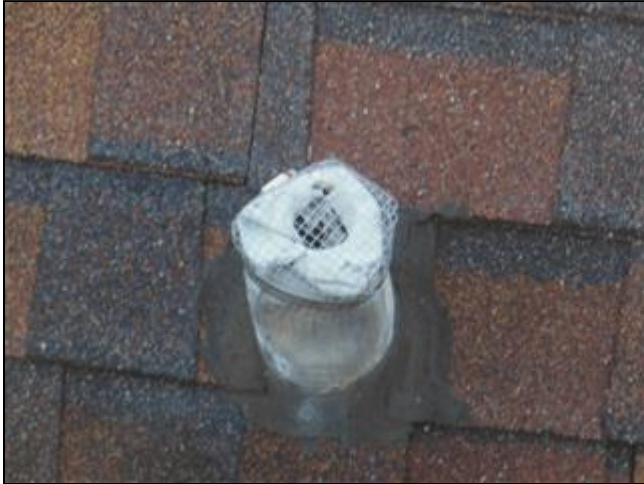
4.7 Picture 1

4.7 [] All plumbing and exhaust vent penetrations appear to be in good condition. A roofing contractor should inspect all facets of this roof on an annual basis and provide the homeowner with written documentation in the form of a report.

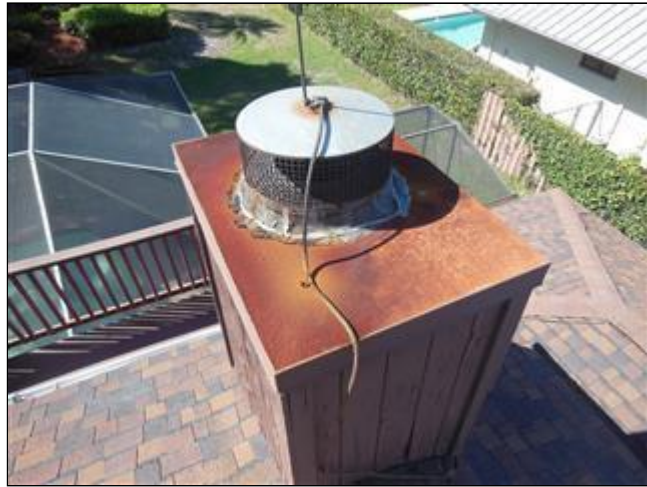
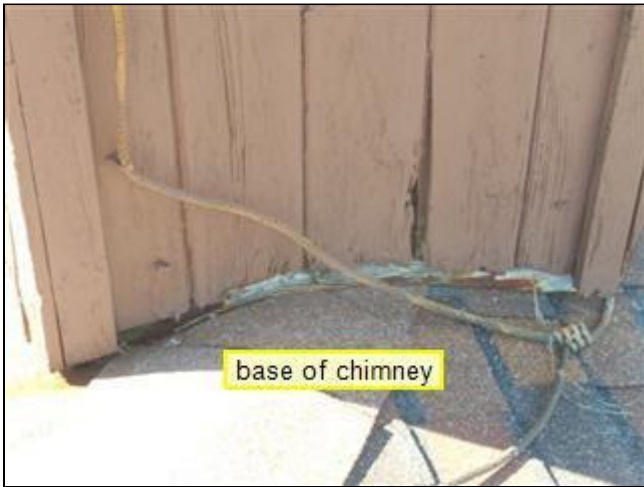
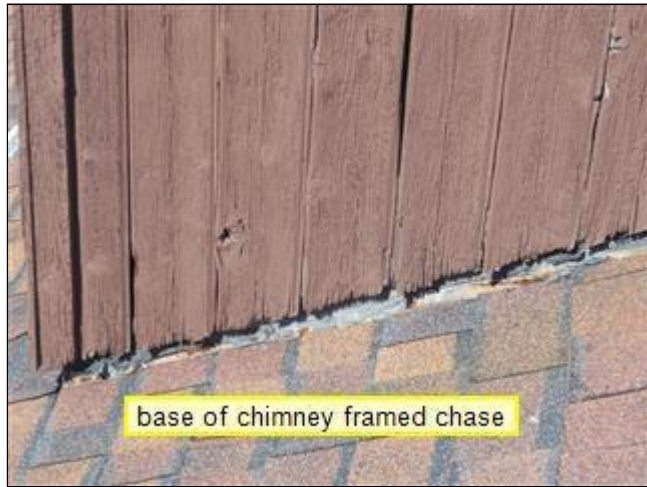
4.9 [] The chimney chase is frame and damaged by wood-destroying organisms and water damage. Wood rot is present, and all areas of affected wood should be treated, or replaced. Rust present. Recommend all components of the chimney, including the flue should be repaired.

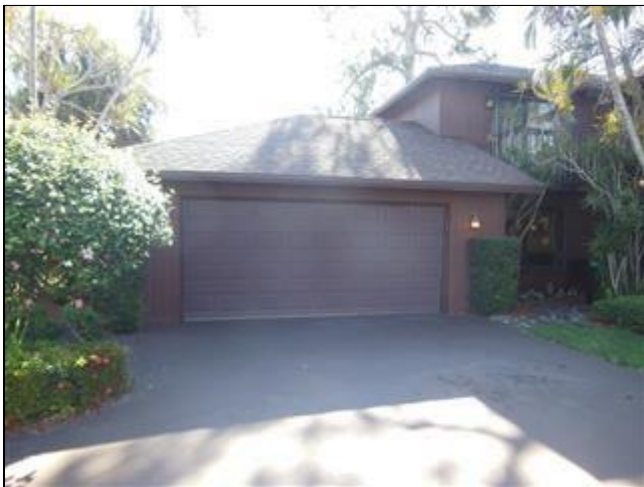
6.0 Picture 1

6.0 Garage door has necessary sensors in place, were tested, and were fully functional at the time of inspection - these sensors avoid children, pets, adults, and valuables from being injured, damaged, or worse yet, fatally wounded.

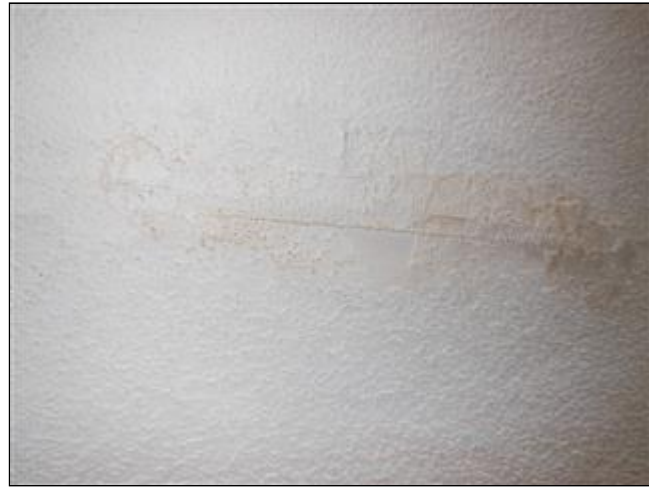
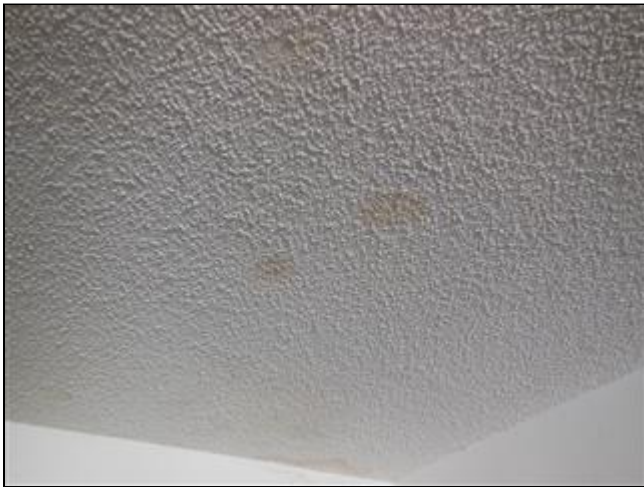
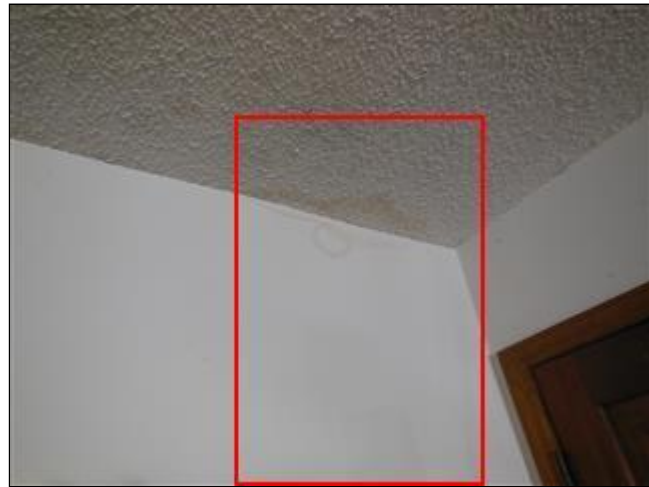
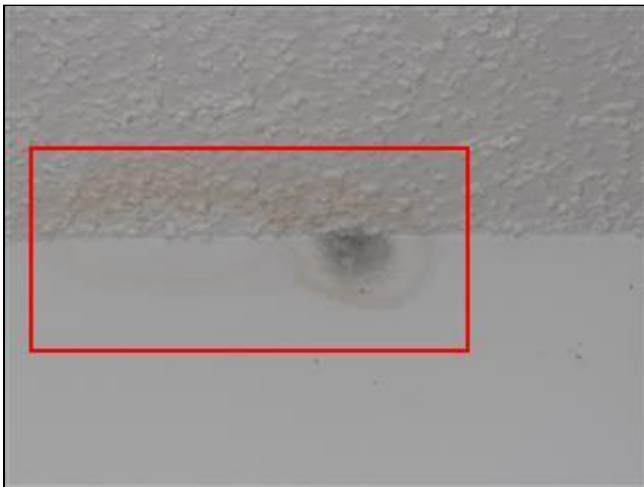
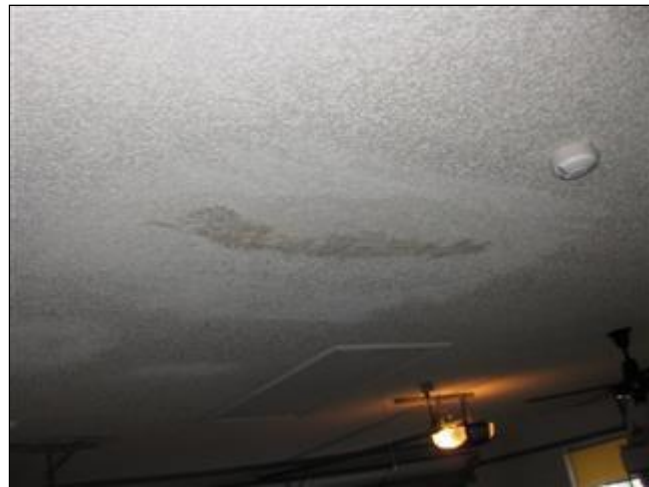
6.1 Portion of garage ceiling is evidence to have had water leaks. The water leaks may be active, or may be from the past; however, ceiling needs to be replaced in all affected areas. Repair work is substandard and should be redone by a licensed drywall professional.

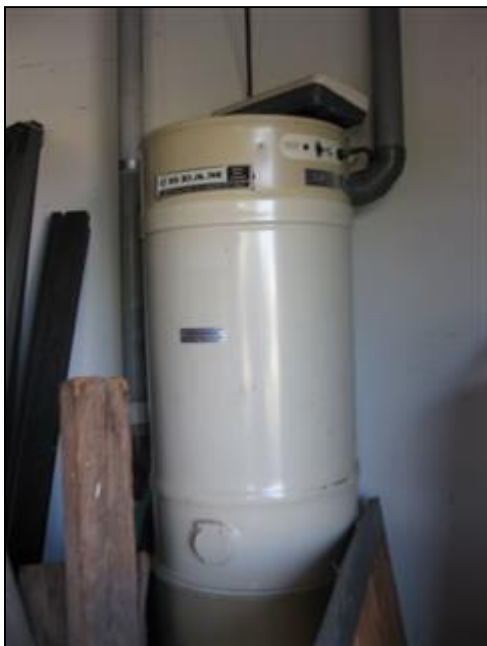
6.6 Picture 1

6.6 [] Optional equipment discovered in garage (central vac) - testing this equipment is not part of a home inspection as it is an optional item. Too many items surrounding central vac. Unable to test it as a courtesy for the buyer.

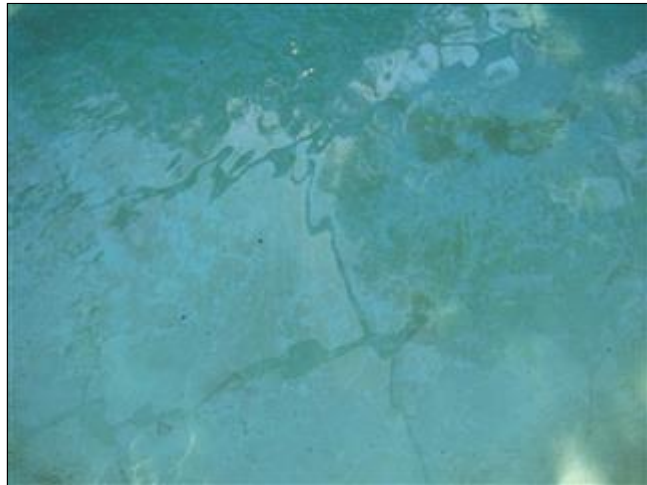
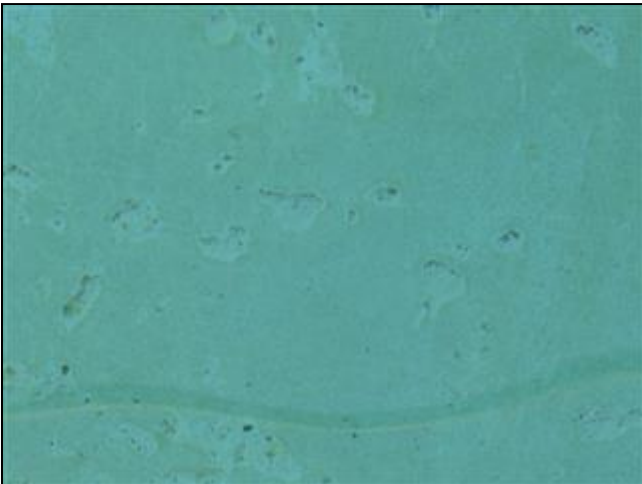
Pool shell - in need of repair and resurfacing as there are many visible compromises and breaches (pitting/chipping) (Pictures 2-3)

Recommend requesting estimates from several pool contractors - main drain cover appears to be properly secured (Picture 4)

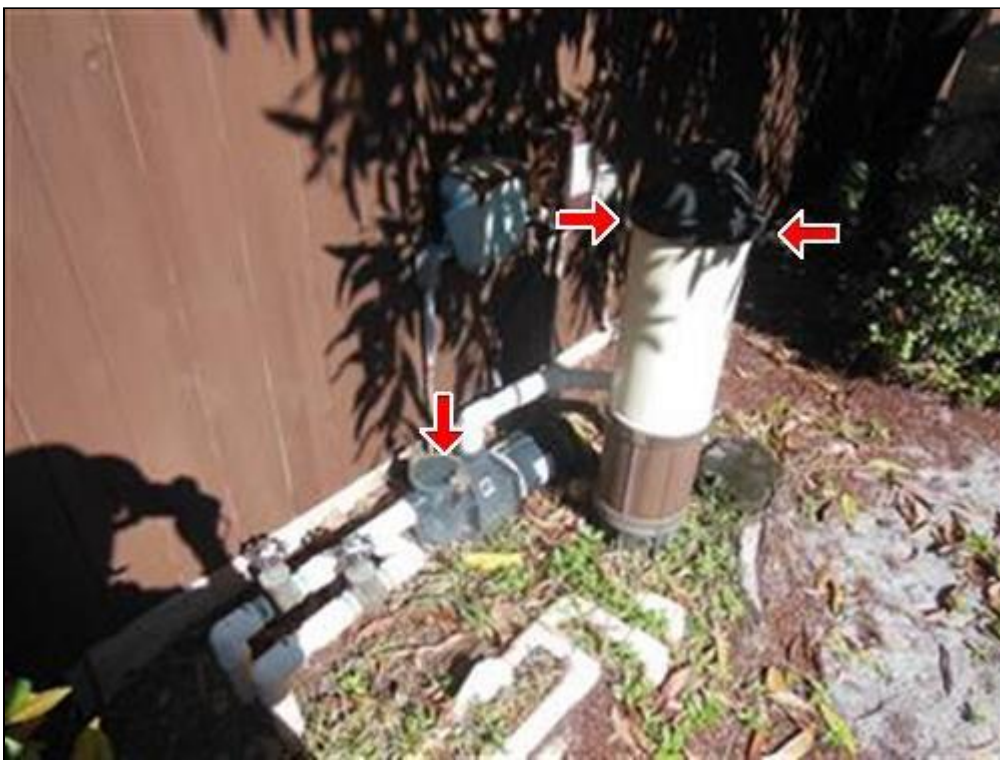
7.2 Picture 2

7.2 Hayward C-750 Pool Filter - was found to be leaking but not consistently leaking - may require new O-ring (gasket) - recommend further evaluation of this and pool pump as it is an old pump (and is half submerged under ground and may need to be replaced in the near future). Pool equipment should be under shade to prolong the life expectancy.

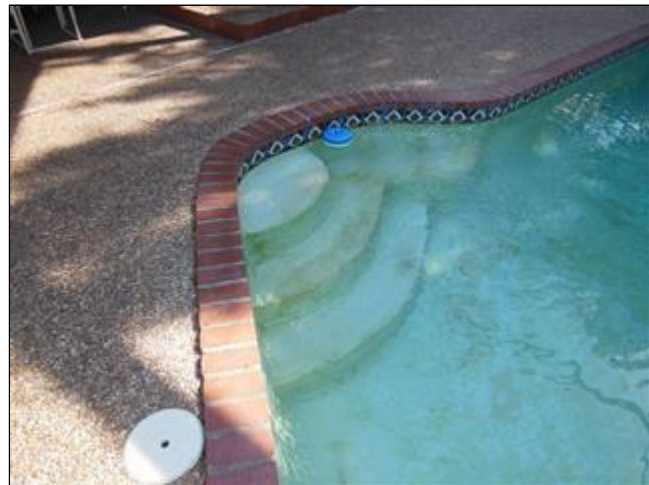
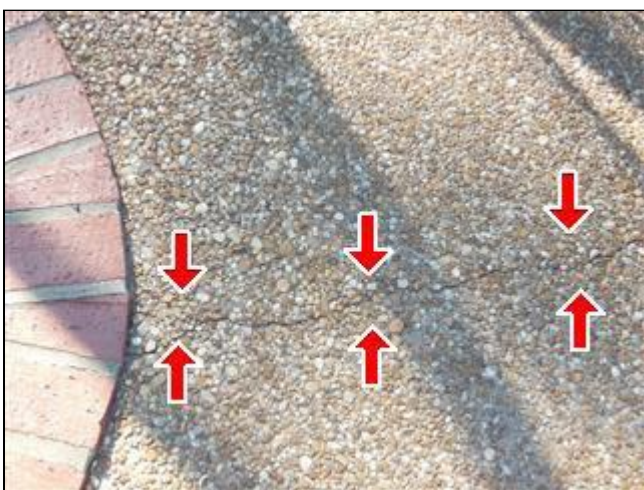
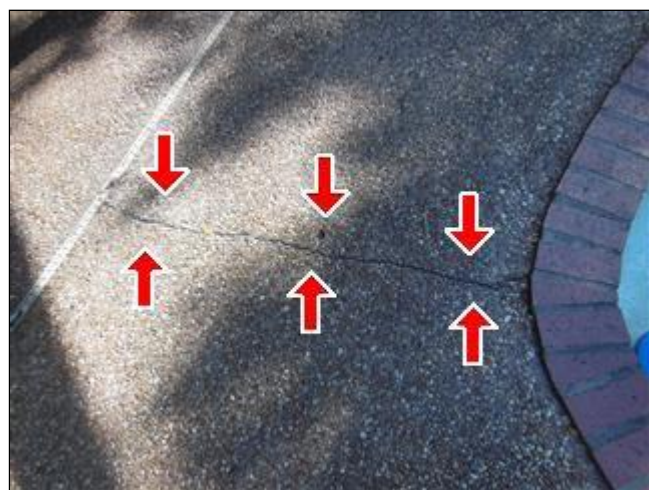
7.3 Pool deck - Chattanooga stone is small, fine pebbles mixed with epoxies to form a deck coating. Unfortunately, ultraviolet light attacks the epoxy which binds this system, and the product begins to deteriorate. The coating becomes porous and attracts bacteria, moisture and fine debris. Many cracks evidenced at the pool deck.

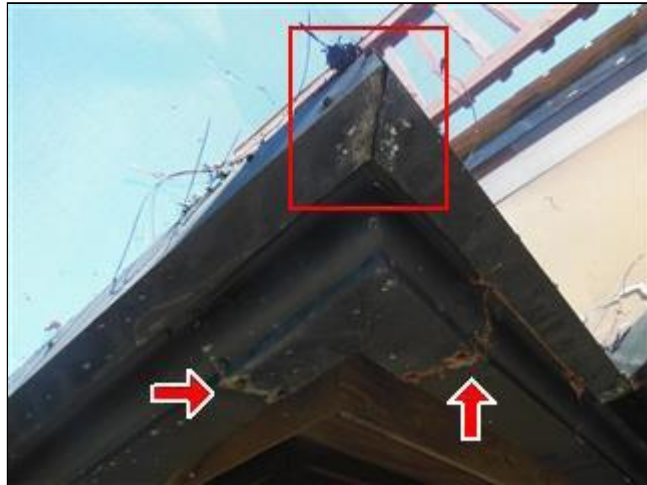
7.4 Picture 2

[] More importantly, the overall pool enclosure structure is in poor condition in some areas. Some braces have rusted through and are in immediate need of repair or replacement. (Picture 2) Also some fascia boards in need of replacement of wood. (Picture 2 within square shape)

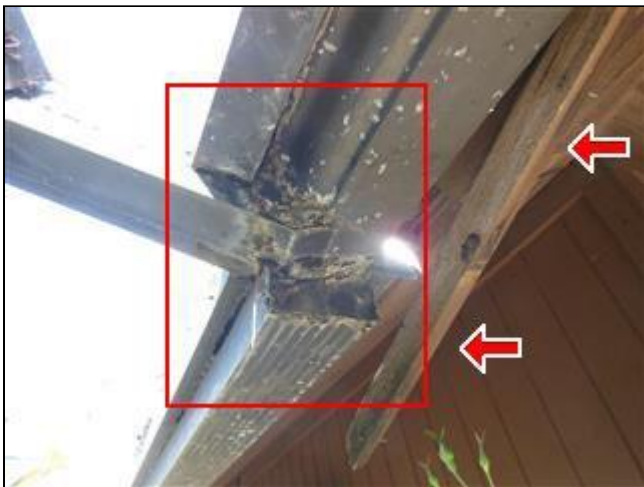
7.4 Picture 3

More photos showing need for repair in several areas, some wood trim, other aluminum bracing/supports. Rusted through bolt holes. (Picture 3)

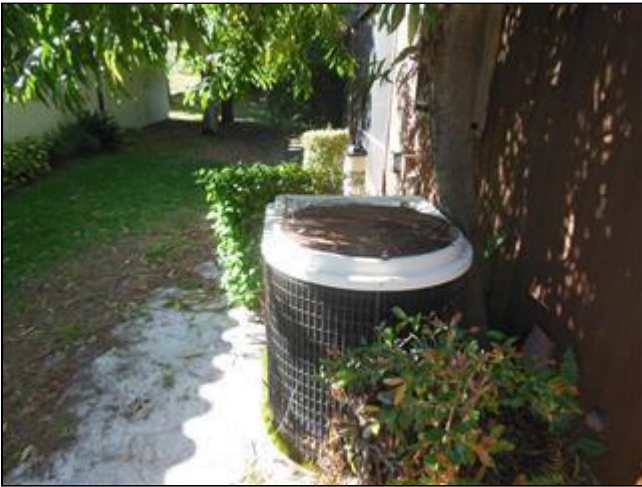
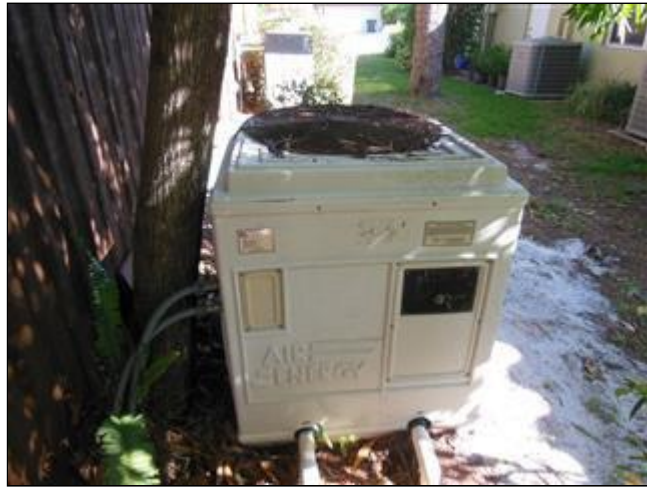
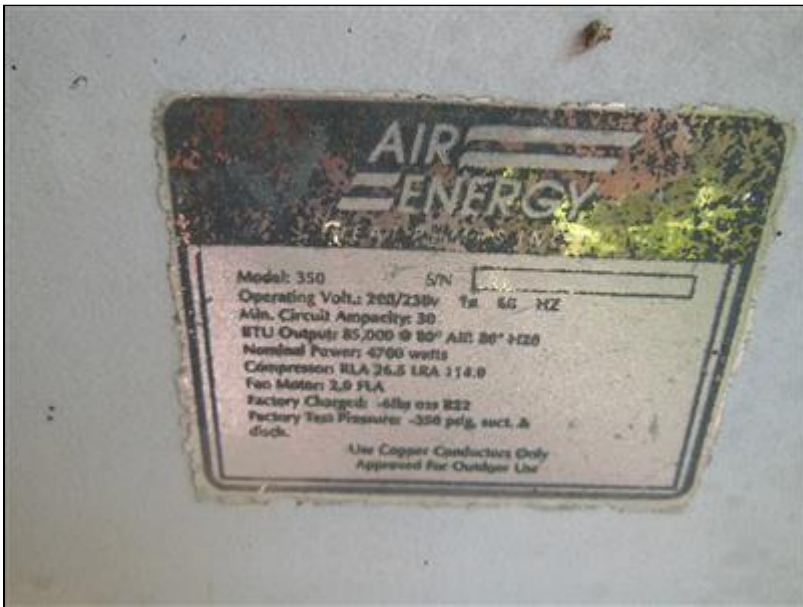
7.5 Pool heater not working.

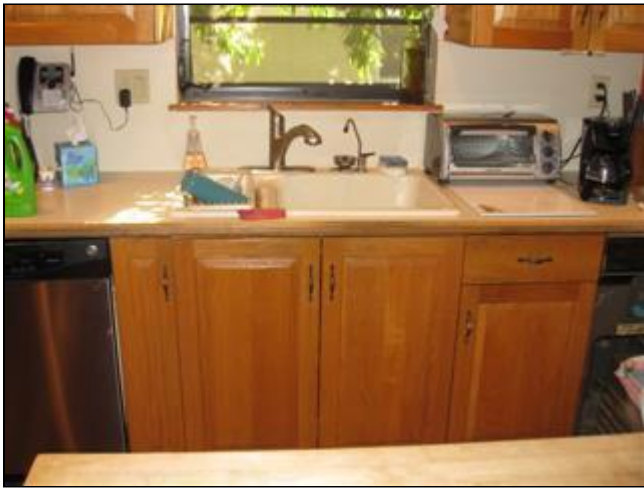
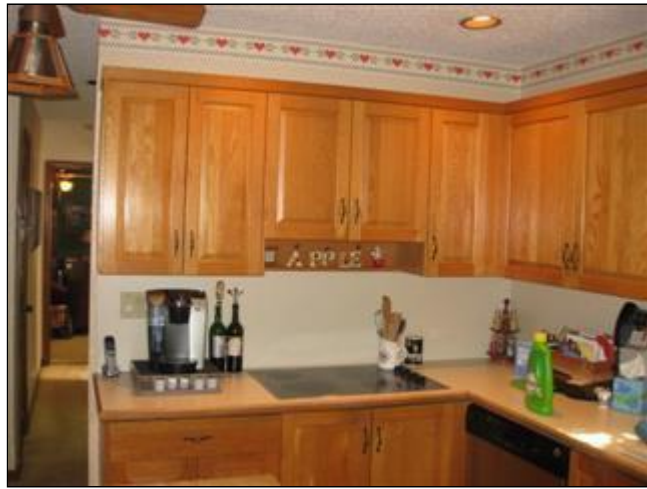
8.0 Photo shown as courtesy to buyer

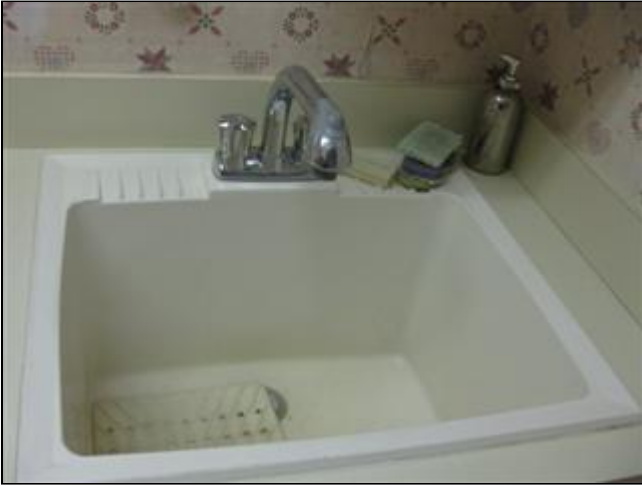
9.9 Picture 1

9.9 Photo shown as courtesy to buyer

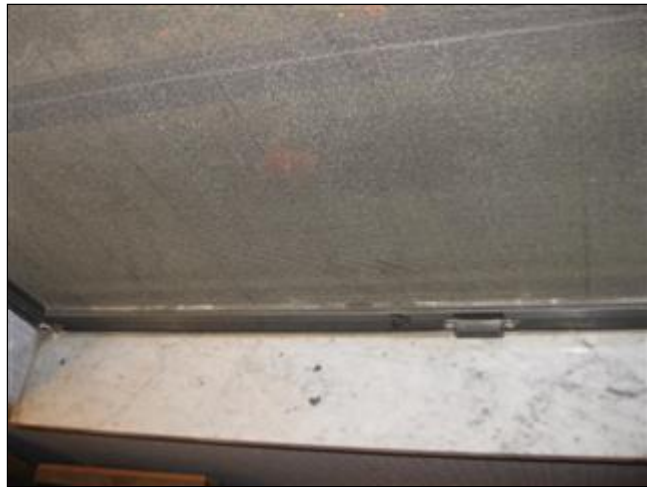
10.2 Picture 2

10.2 [] A number of windows in bathrooms were tested for functionality. Fixed pane glass windows in all areas need repair (new seals as the ones in place have deteriorated), same goes for awning vent windows in bathrooms. New seals are necessary.

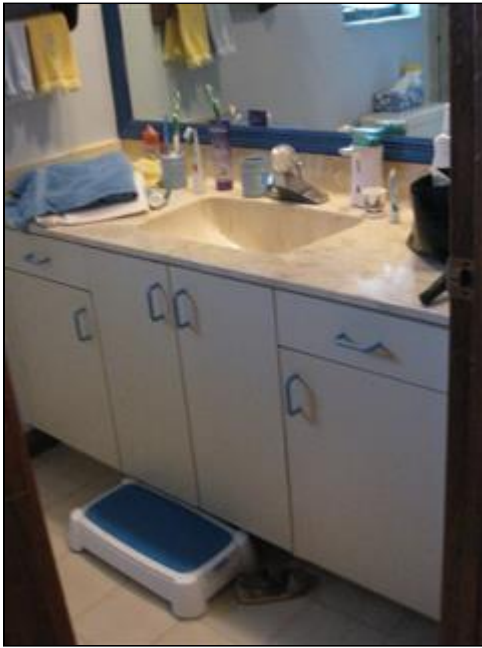
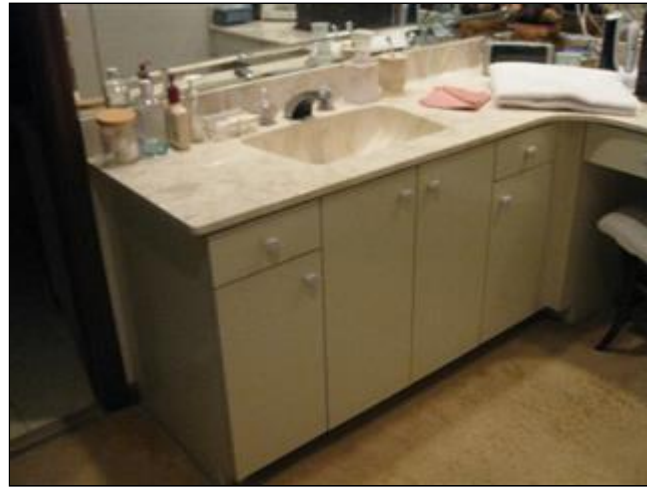
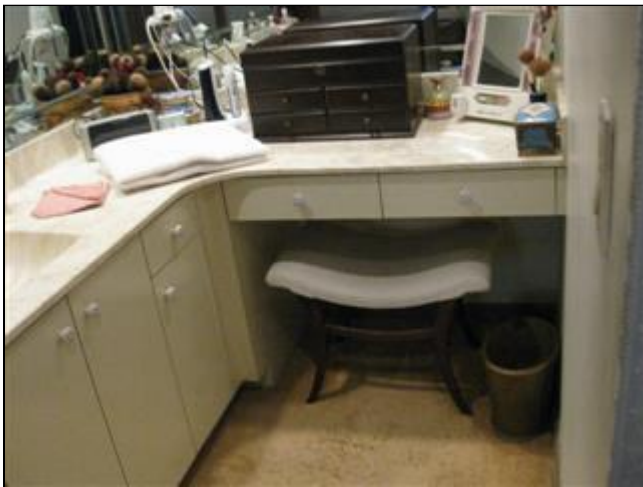
10.3 [] Cabinetry in all bathrooms appears to be original. All cabinetry in all bathrooms should be removed and discarded.

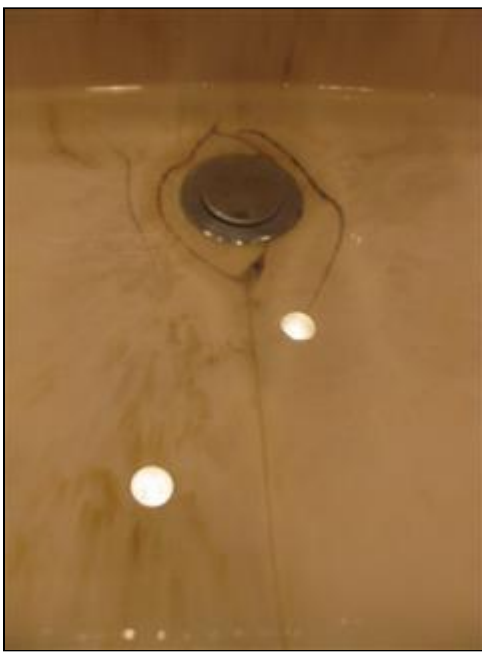
10.5 Picture 3

Sink in the master bathroom to the right of incomplete shower has a crack in the bowl of the sink. (Picture 3) Does not appear to be leaking at time of inspection. May wish to replace sink, or seal it and stain it.

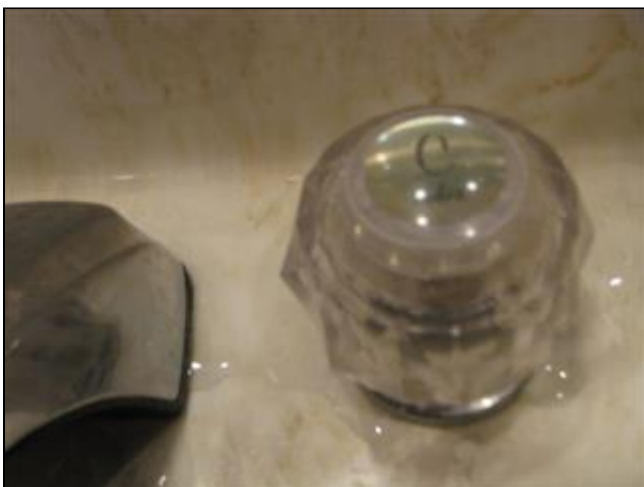
10.5 Picture 5

10.5 No evidence of plumbing leaks in any of the bathrooms under the sink vanity cabinets, or toilet plumbing valves. But there is evidence of leaks at the handle fixture on several sinks. (Picture 5)
