Inspection Report

Property Address:
1234 Main Street
City State Zip Code

US Building Inspectors, Inc.

Date: 0/00/0000	Time:	Report ID: 7988SampleReport
Property: 1234 Main Street City State Zip Code	Customer: Your Name Here	Real Estate Professional:

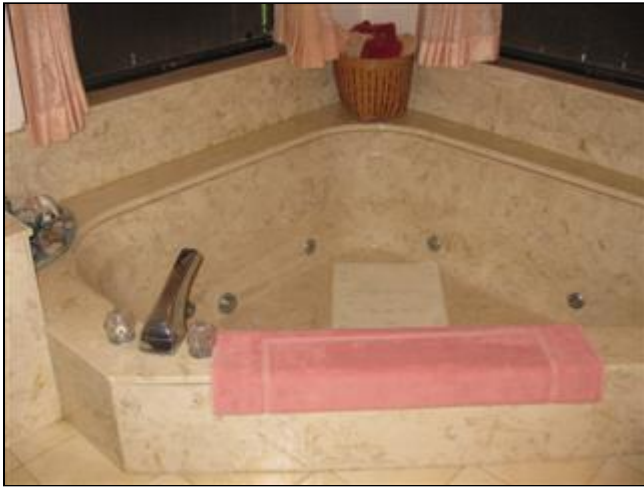
10.6 Picture 5

[] Spa tub in master bathroom was unable to be tested. Tried to fill it with water to fill over the jets; however, due to bottom of tub having a severe crack (Picture 8), the tub did not fill with water. Emptied tub of water and was unable to test spa tub motor. (Picture 5)

Spa tub in master bathroom was unable to be tested. Tried to fill it with water to fill over the jets; however, due to bottom of tub having a severe crack (Picture 8), the tub did not fill with water. Emptied tub of water and was unable to test spa tub motor. (Picture 5)

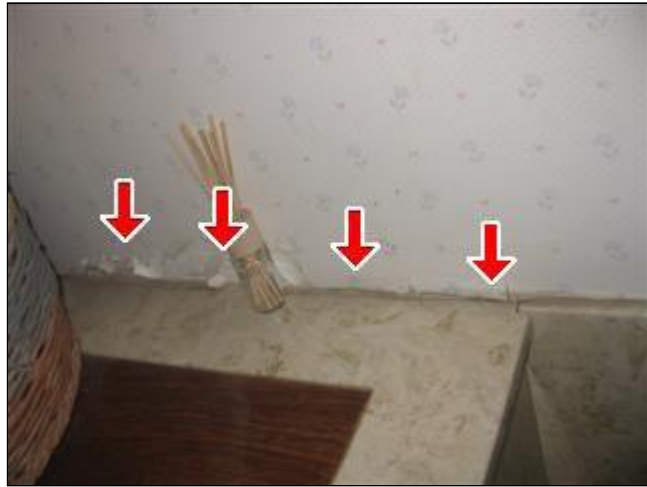
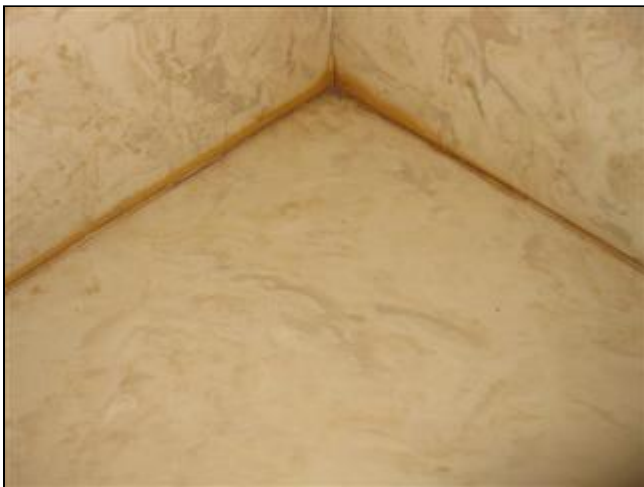
Unable to access motor for spa tub due to it being sealed in an encasement in the master bathroom. (Pictures 6-7)

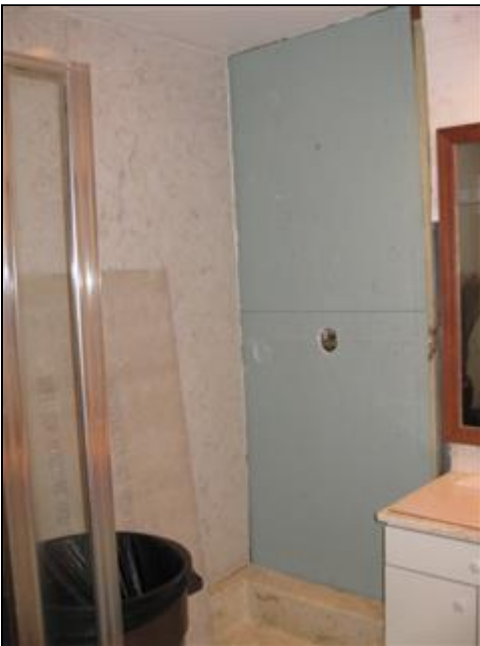
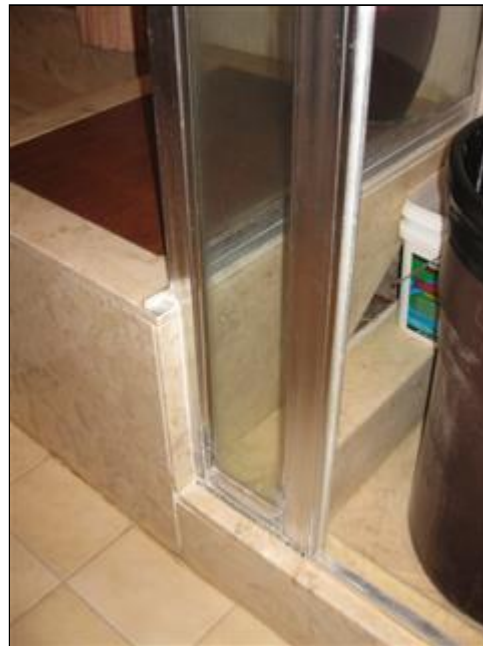
10.7 [] Shower in the master bathroom is at an incomplete construction state. Recommend this area be finished. (Pictures 3-4)

Shower in the master bathroom is at an incomplete construction state. Recommend this area be finished. (Pictures 3-4)

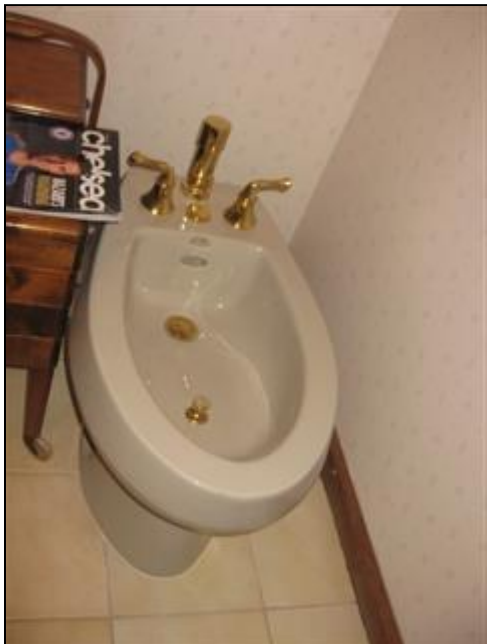
10.8 Picture 1

10.8 [] Bidet in the master bathroom needs new hardware. Water is distributing properly, but when spray through diverter is activated, water is not able to spray through the diverter due to calcification having occurred.

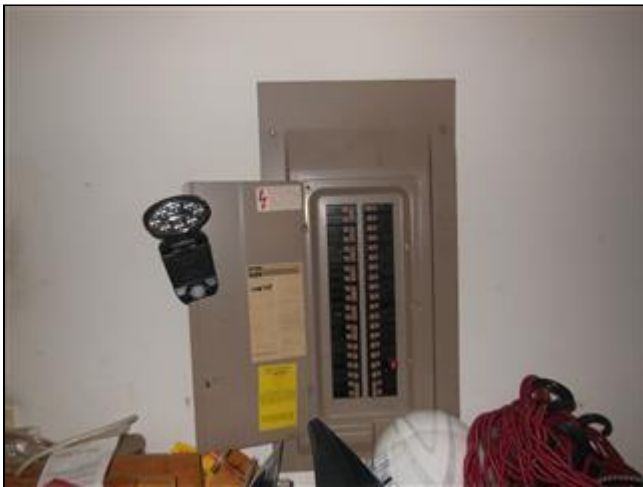
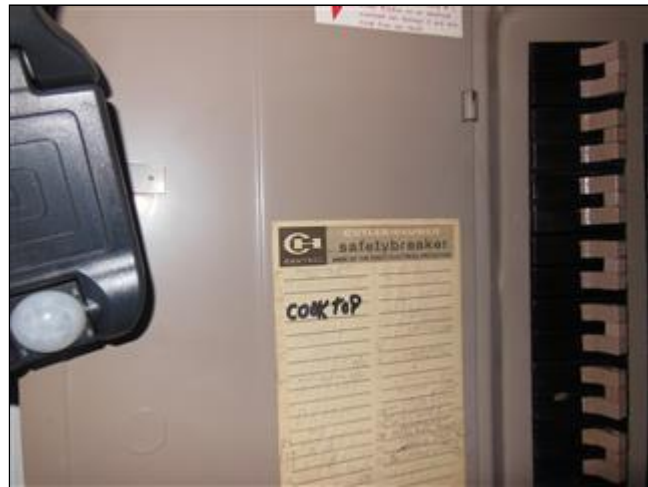
11.0 Main distribution panel located in garage on south wall.

Main electrical shut off it outside on East wall next to the main service panel, 200 amp main.

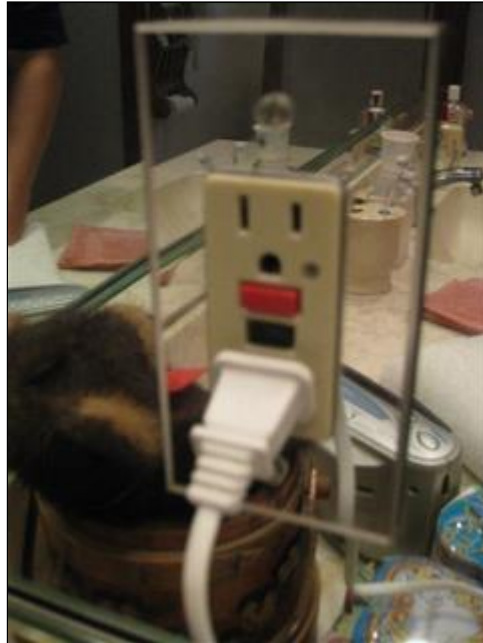
11.3 Picture 2

[] Hot electrical receptacle in the master bathroom vanity sink area - informed seller's daughter of arcing present. Critical that a licensed electrician should repair this immediately to prevent fire. (Picture 2)

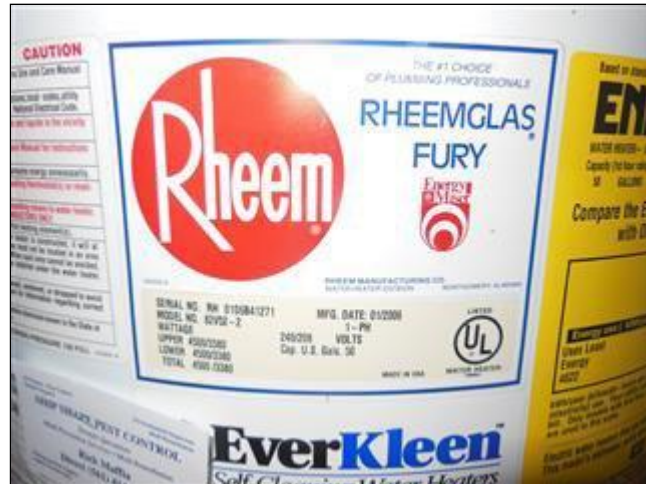
13.0 Picture 2

[] Water heater has many personal stored items surrounding it. This is a safety hazard. Nothing should be close to the water heater or stored around it. Water heater should have drain pan.

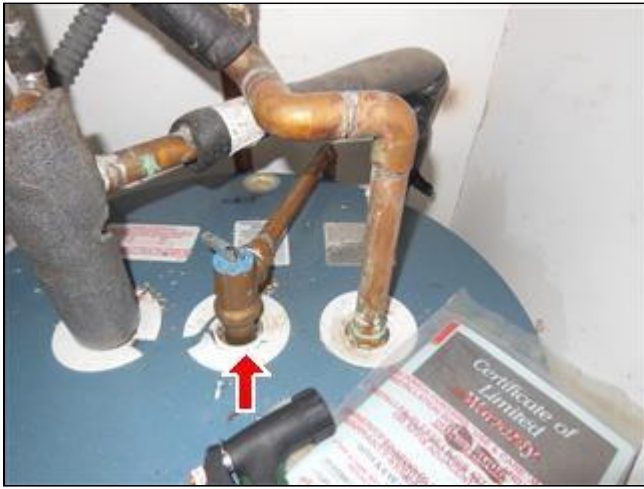
13.2 Picture 1

13.2 Photo shown as courtesy to buyer

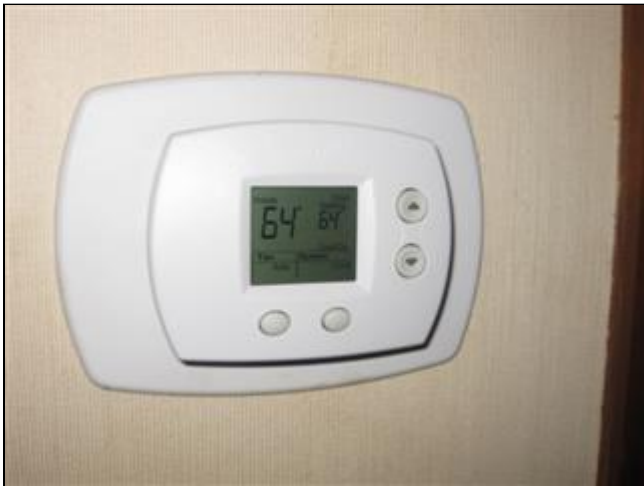
14.0 Picture 1

14.0 3 thermostats - 1 in the master bedroom, 1 in the family room which is next to the garage, and 1 upstairs in the hallway

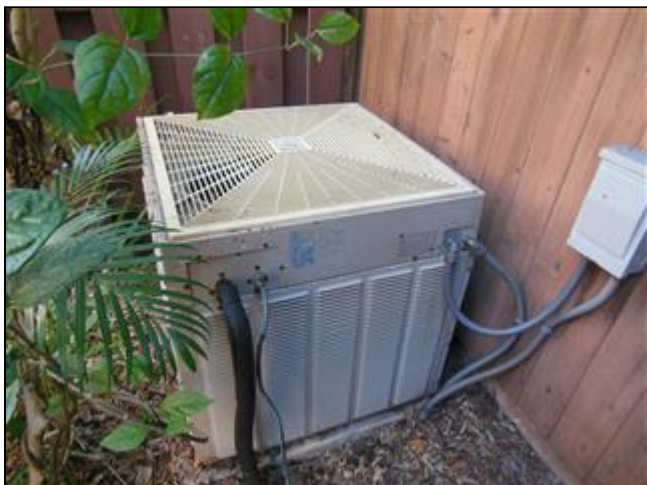
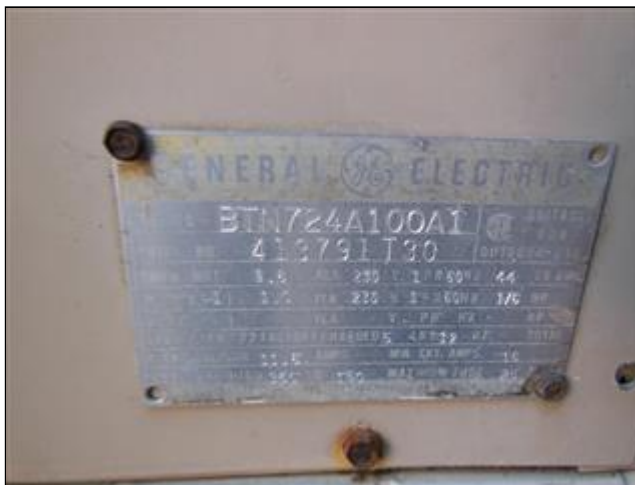
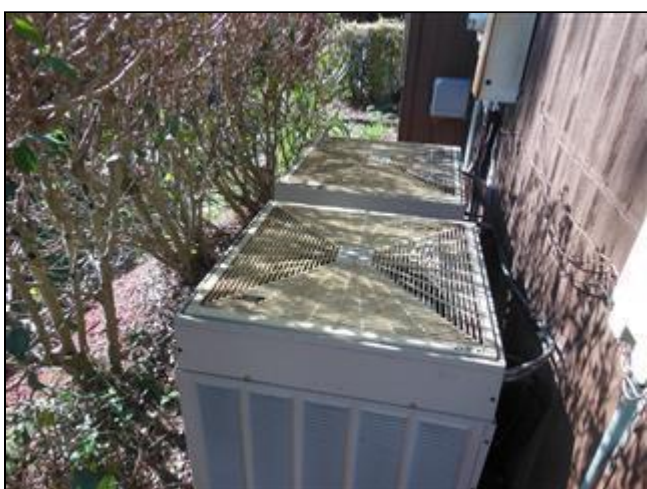
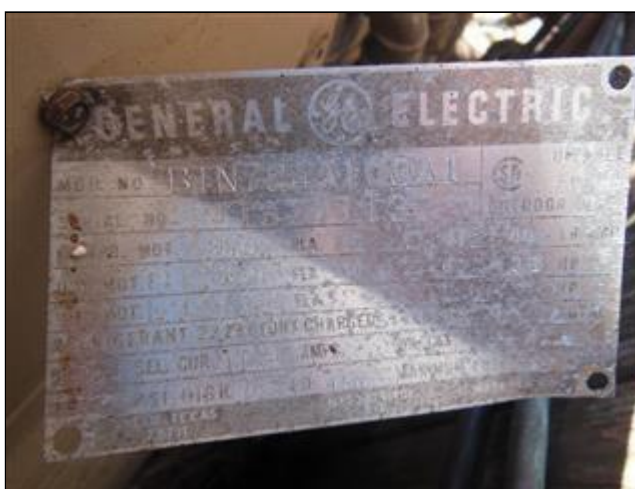
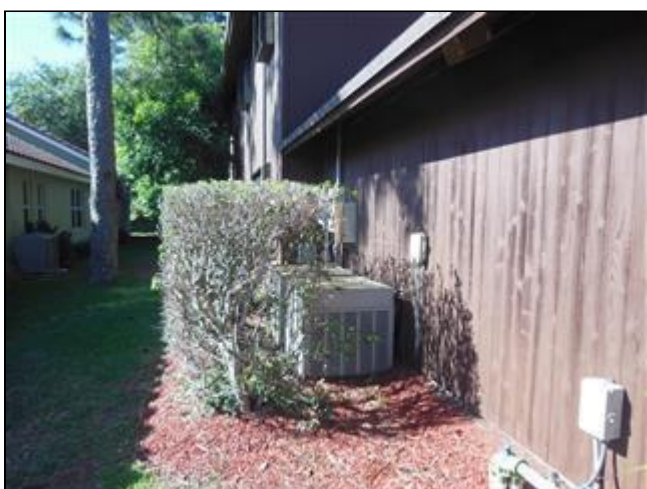
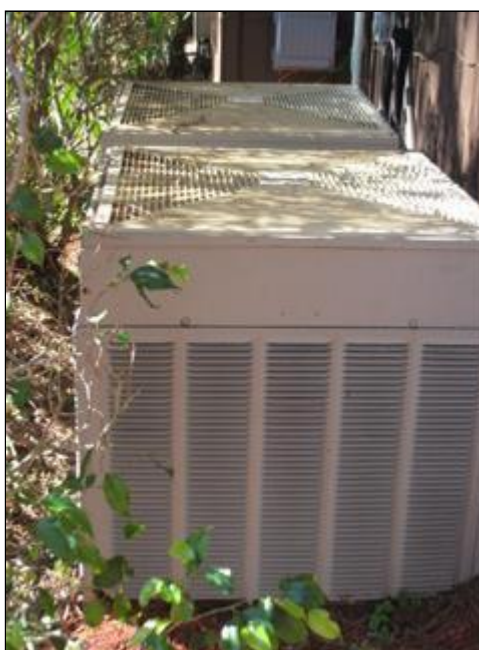
14.1 Condenser Brand: GE manuf 1980 33 years old

Condenser Brand: GE missing label but is most likely 1980 also

> Age / Date code places this unit near the end of the manufacturers intended design life. Budget for future replacement.

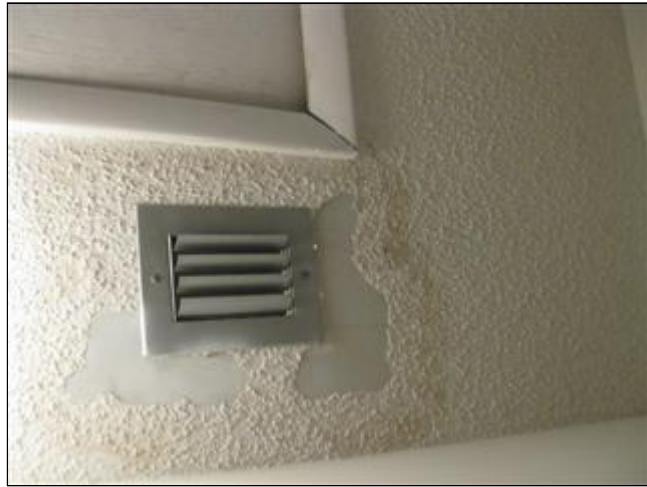
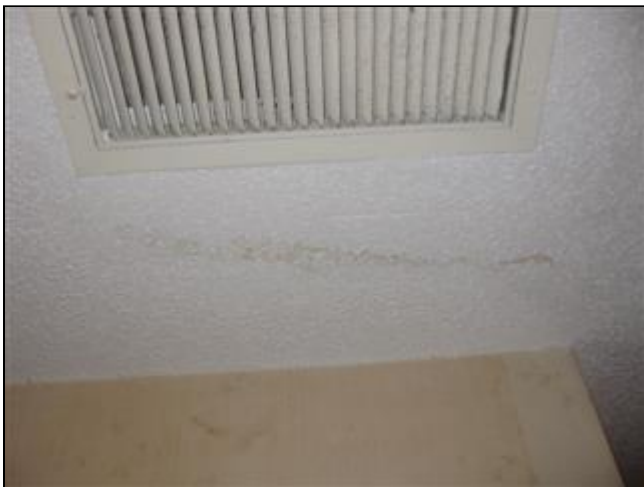
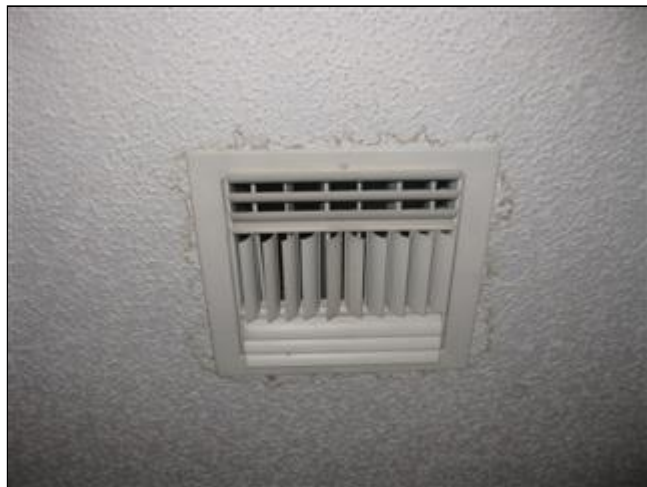
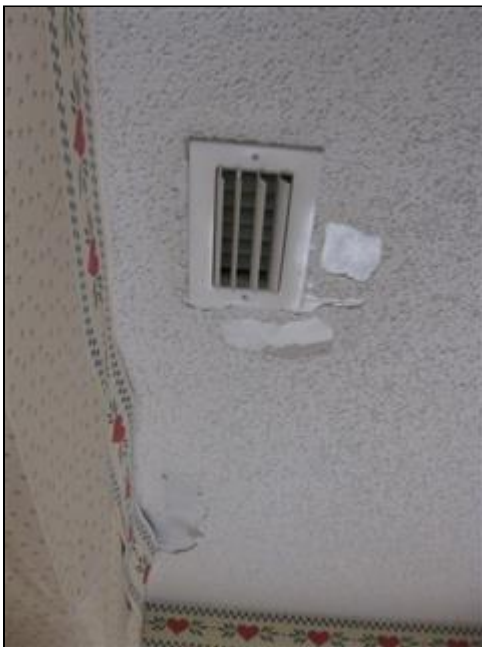
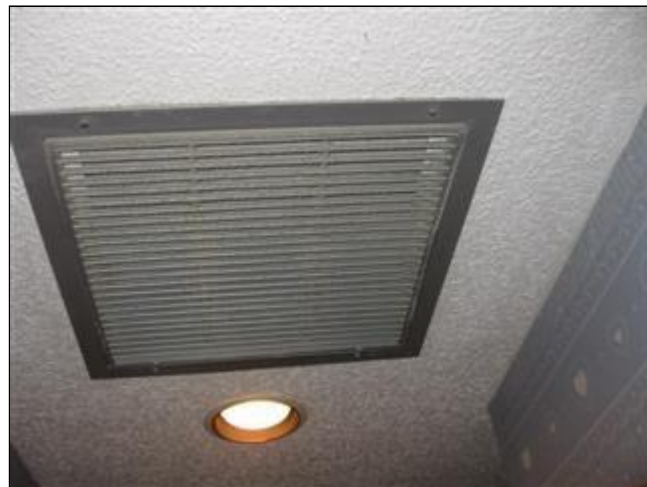
14.2 Evidence of past leak by registers/vents and intake/return.

Intakes and registers are filthy with dust and allergens. Duct work loaded with dust, wet moist mold-like substances, and in need of thorough cleaning and sanitizing.

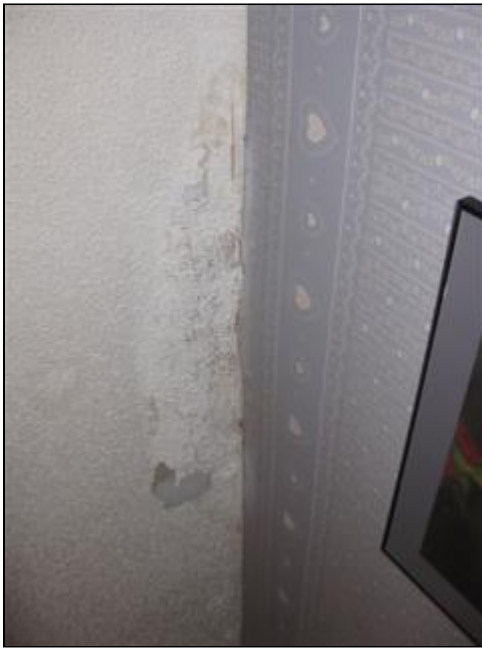
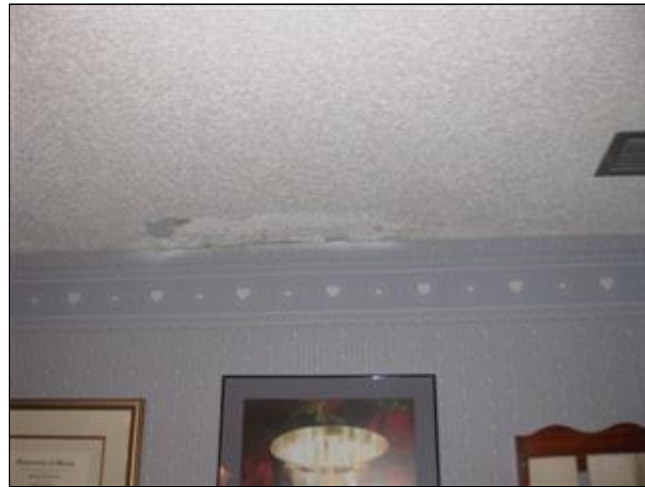
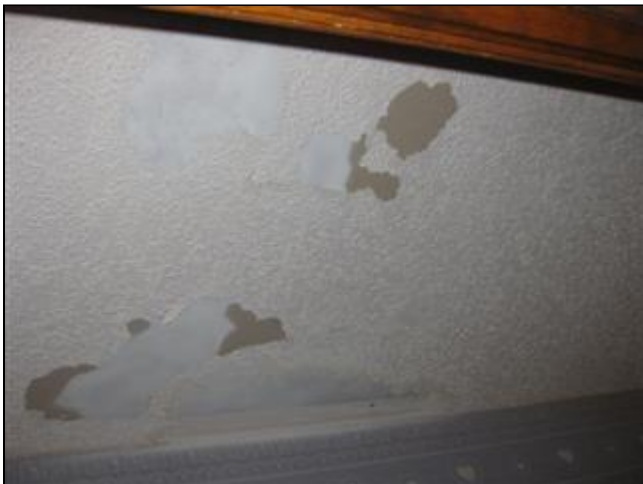
15.0 Many areas of the interior ceiling is evidence to have had water leaks. The water stains appear to be from the past; however, ceiling and walls near these water stains need to be replaced in all affected areas.

[] Ceiling patch in master bedroom was said to have recently been leaking, but repaired at the exterior, and patched at the interior. If this leak has indeed been repaired at the exterior roof flashing, it would be wise to allow time for many days of hard pounding rain prior to replacing ceiling drywall in master bedroom in this area.

[] All floors with carpeting and padding should be removed of these items entirely.

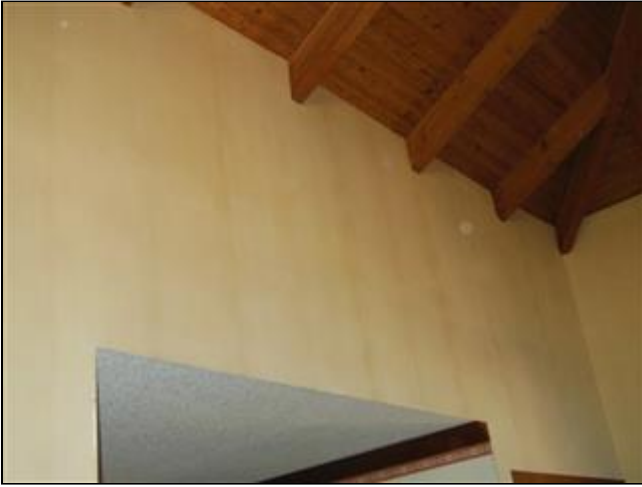
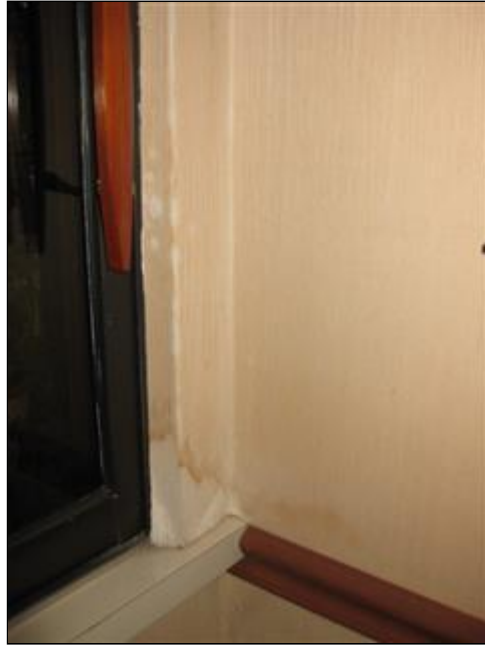
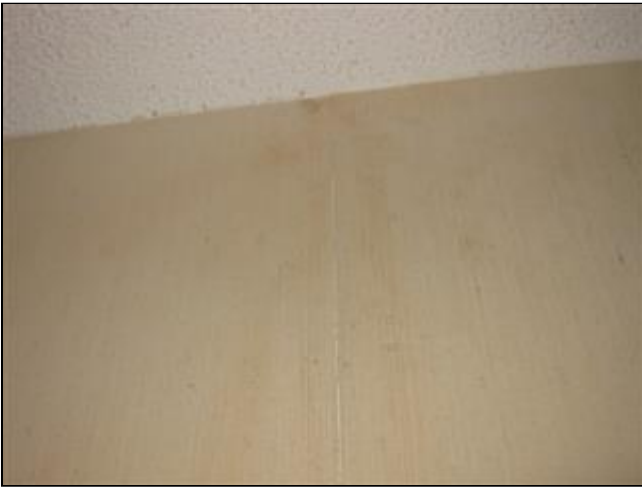
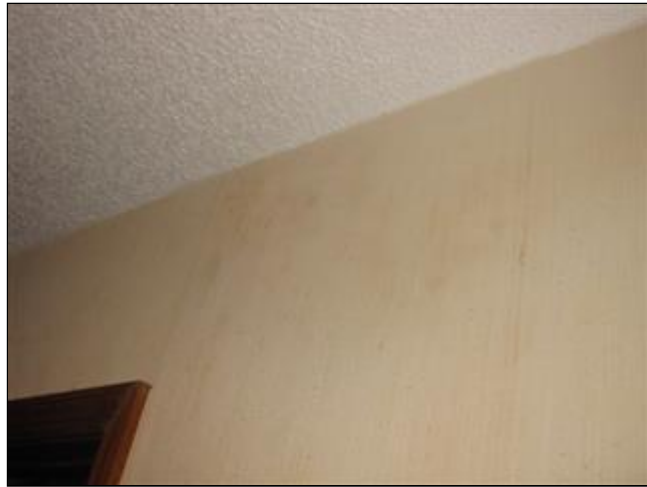
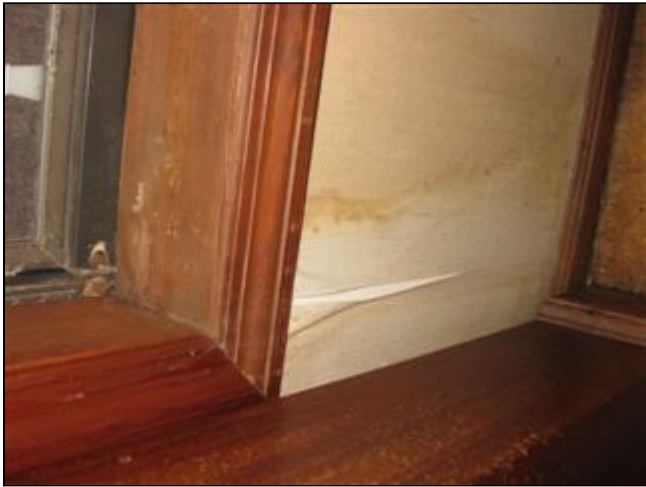
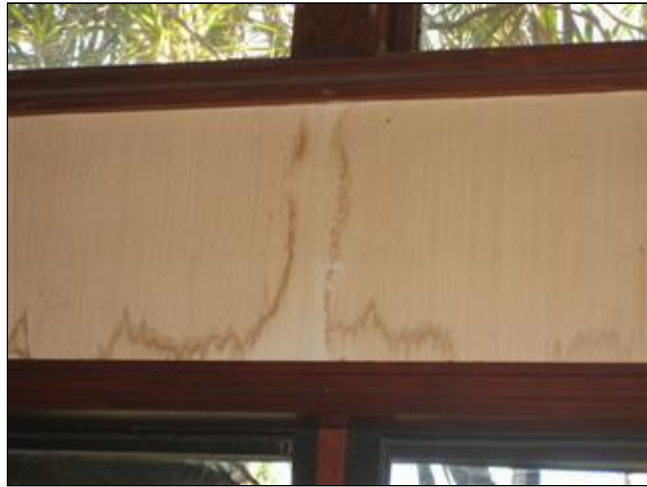
The 1st level walls in every room of the house have been affected by water damage.

The water leaks appeared to have been going on for a long period of time evidenced by the large amount of ceiling water damage and wall water damage.

16.1 See Section 15.1 for important information concerning walls in the home.

The water stains appear to be from the past; however, ceiling and walls near these water stains need to be replaced in all affected areas.

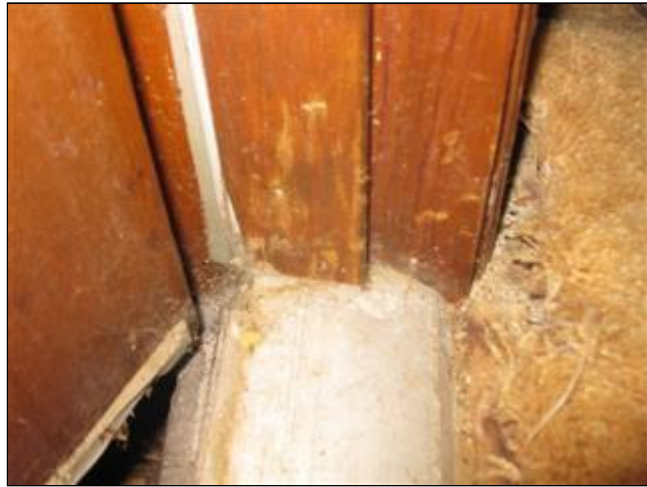
16.3 Picture 2

16.3 [] Double wood entry and egress doors have been affected by water damage from the past and are showing signs of delaminating.

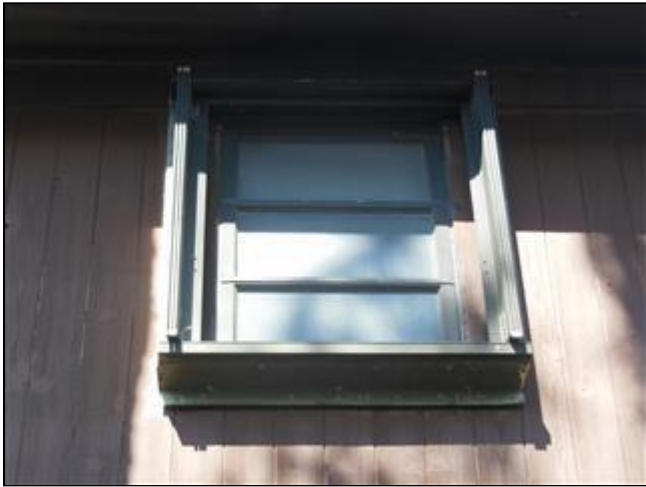
16.4 Picture 1

16.4 [] A representative number of windows in common areas of the home, bedrooms, bathrooms, were tested for functionality. Fixed pane glass windows in all areas need repair (new seals as the ones in place have deteriorated).

[] Due to water damage (intrusion) having infiltrated 1st floor bedroom and master bathroom windows from sprinklers, it is important to know that the moisture, condensation, or rainwater seeps in through window seals (which have long been breached).

The windows in this home have not been properly maintained. The windows, especially on the first floor have water damage, but inside the walls, which have then flowed into/onto the floors, as well as the baseboards/trim.

[] Due to roof leaks, the 2nd floor windows (water damage/water intrusion) has occurred not only at the window areas, but also in the walls, baseboard, and in some of the closet areas where moisture levels with the moisture meter was very high.

ALL windows need to be re-sealed and wiped down and sterilized prior to any build back being done (after mold remediation has been completed and air tests determine there is an "all clear" inside the home).

It is recommended to use a heavy duty marine sealant, not available at home improvement stores. Other heavy duty sealants are acceptable - one is typically used for roofing sealant, and is not made for windows. This is also a good choice.

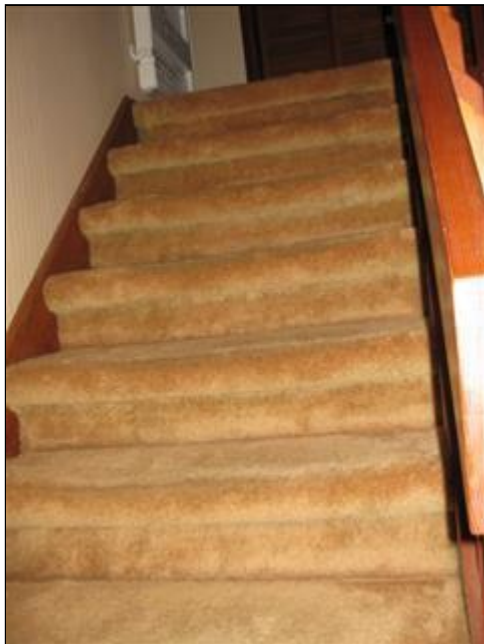
16.5 Picture 2

16.5 [] Carpeting and padding needs to be removed from stairs. The handrails appear to be in good condition and are secure. Handrails should be reinspected quarterly by the homeowner.

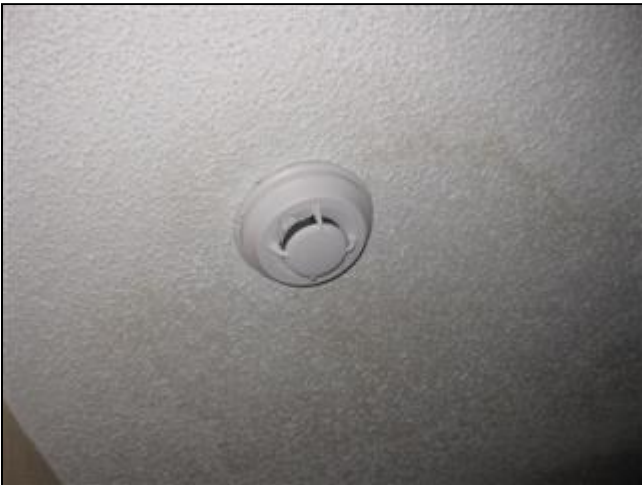
17.0 Picture 1

[] Defective / not operating smoke detectors in limited areas.

[] Carbon monoxide detectors missing.

17.0 <> Recommend replacing all smoke and carbon monoxide detectors age 5 years and older as they lose their sensitivity.

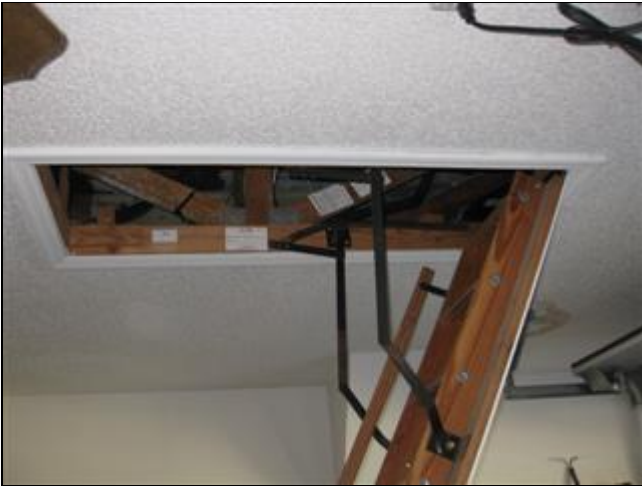
18.0 Picture 1

(2) Scuttle hole in little boys bedroom closet upstairs

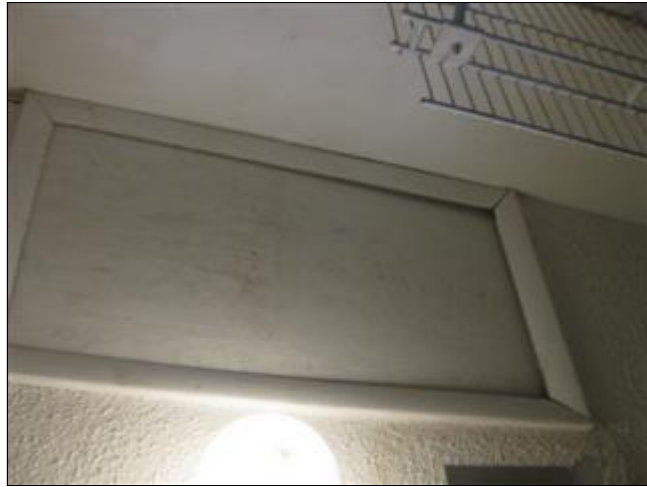
18.0 Picture 2

(3) Master bedroom closet on the right hand side has scuttle hole.

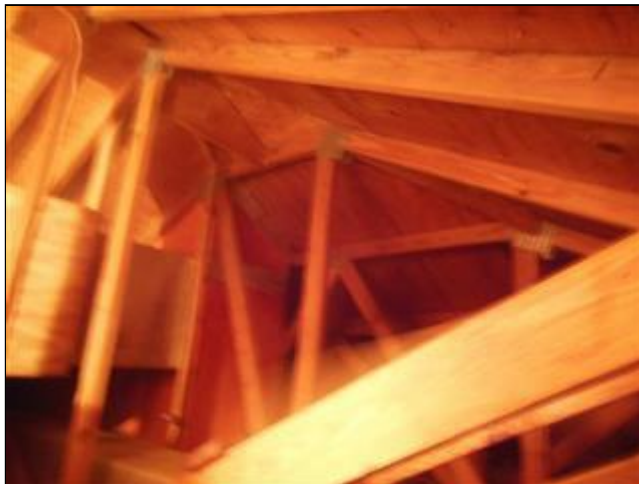
18.1 Picture 2

18.1 [] It should be noted that some evidence of drywood termites and subterranean termites was present both inside the home and outside the home on trim and fascia.

Evidence of subterranean and drywood termites present. Buyer or Seller should have wood-destroying organisms treated and affected wood structures replaced.

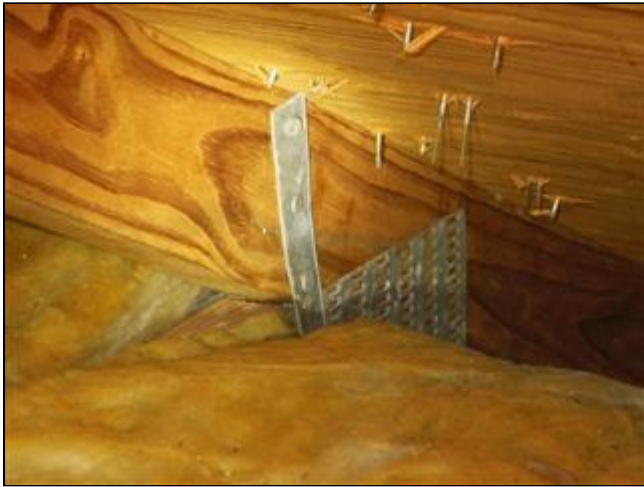
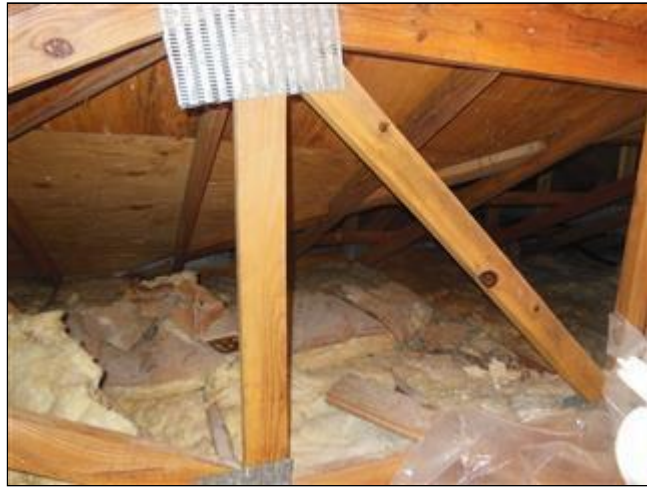
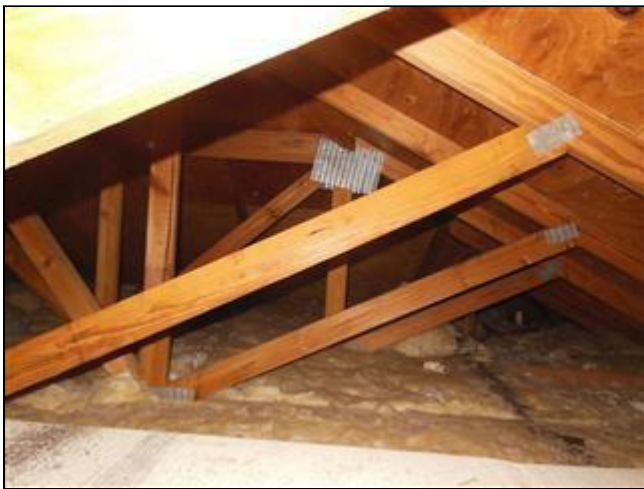
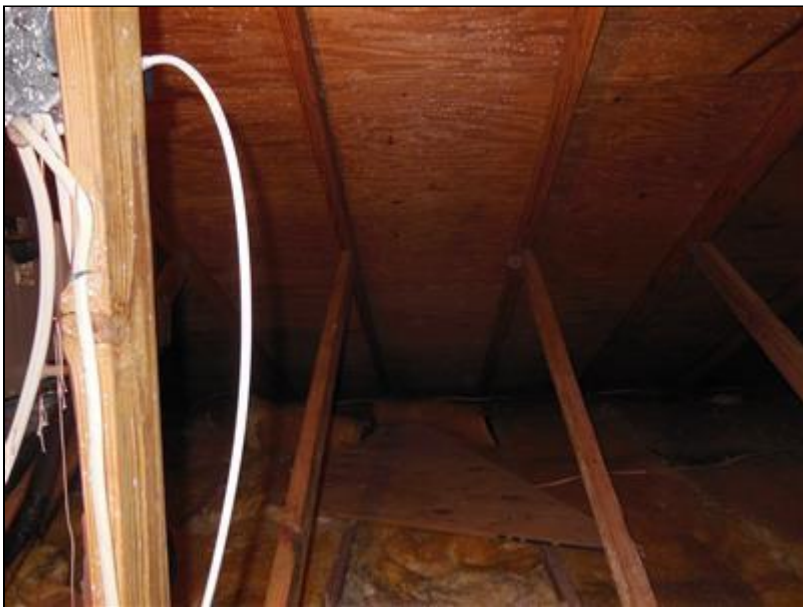
18.2 [] Loose / displaced insulation at the attic floor in limited areas throughout.

All new insulation in attic should be installed. Present insulation should be removed and discarded.

< Recommend a free energy survey be performed by FP&L for possible upgrade credit.
